Abertay Historical Society Fieldwork Division

Worked Stone Record

Stones from St Mary's Church in Balgay Park

Abertay Historical Society Field Division and Friends of Balgay recorded the stones in 2016 and undertook a condition check in 2021. The attached record sheets are from the 2021 condition.

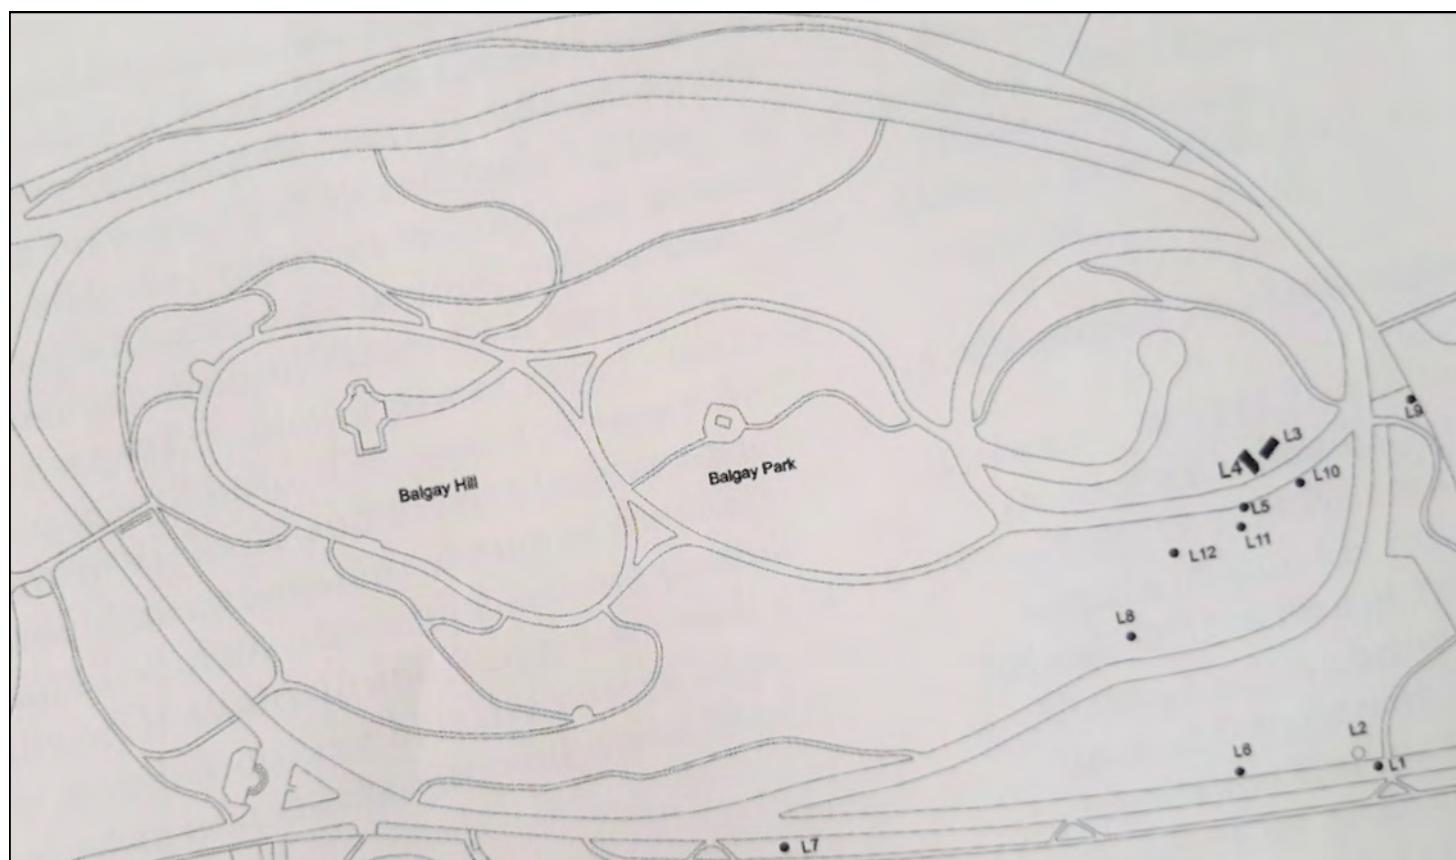
Plan of investigated site in Balgay Park

The location of the stones in Balgay Park is indicated by figure 2 in the attached plan. Balgay Hill Recreation Grounds and Cemetery officially opened 20 September 1871 – gifted by the Cox Brothers

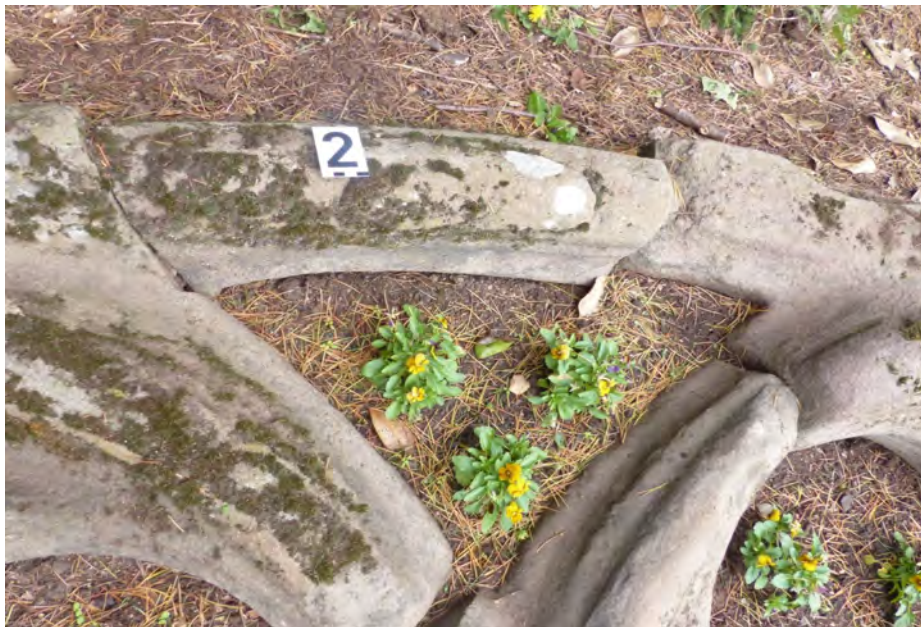
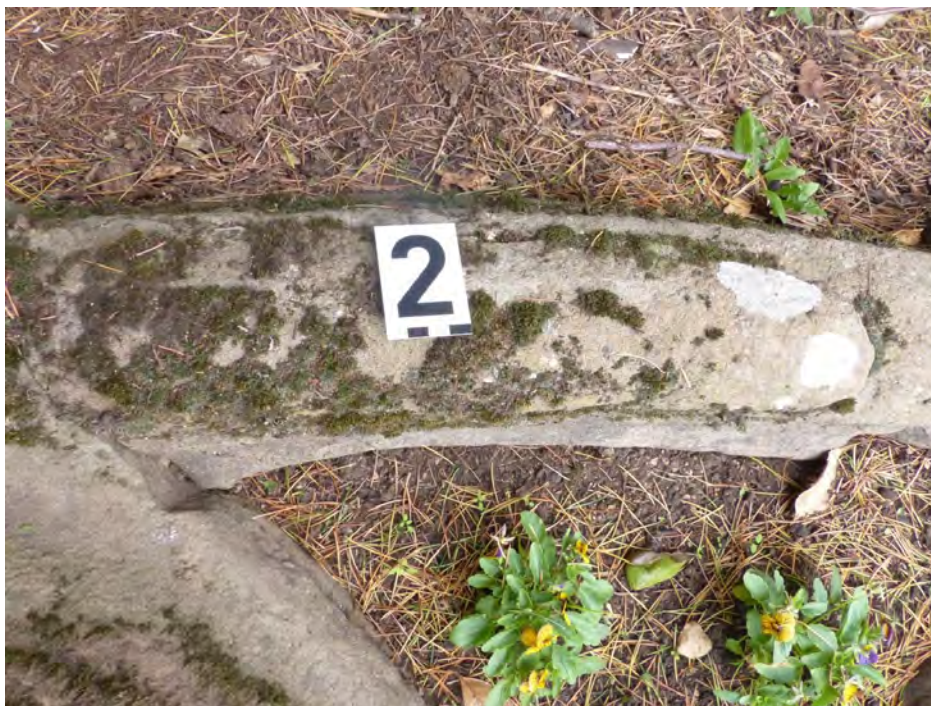
Date: 25/09/21	Stone #: BP 2-2 SUAT cross reference # 2	Recorded by: CS CD
Site: Balgay Park	Photo # 5-8,10

Damage: Delamination top surface, moss

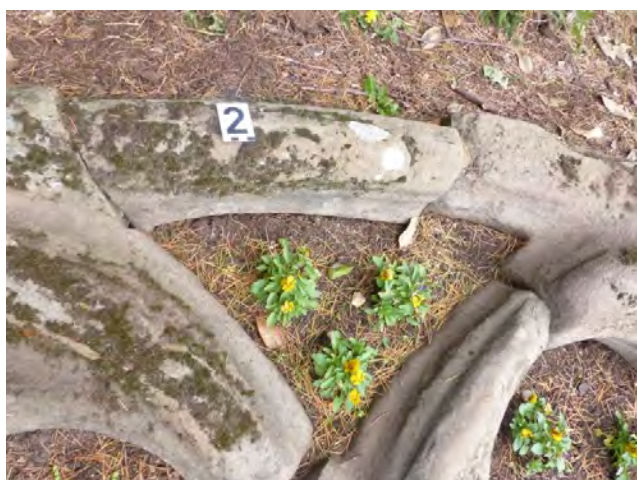
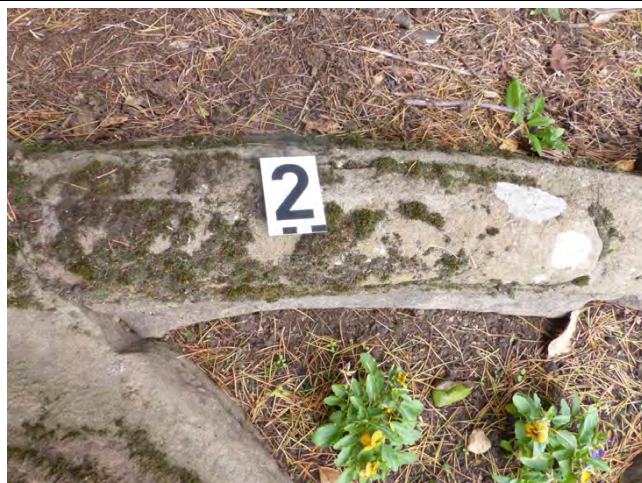
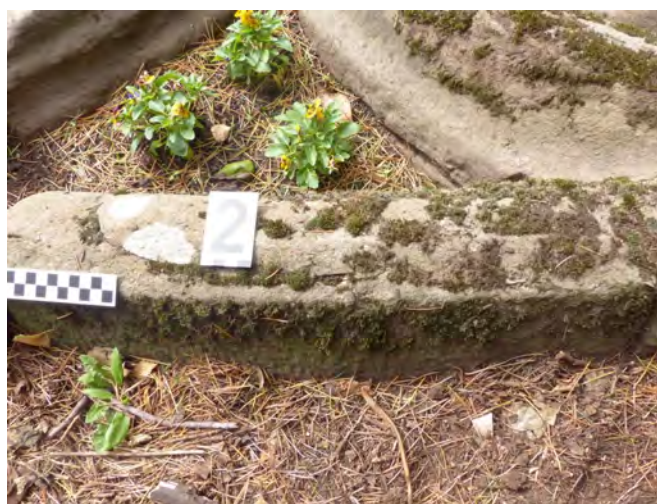
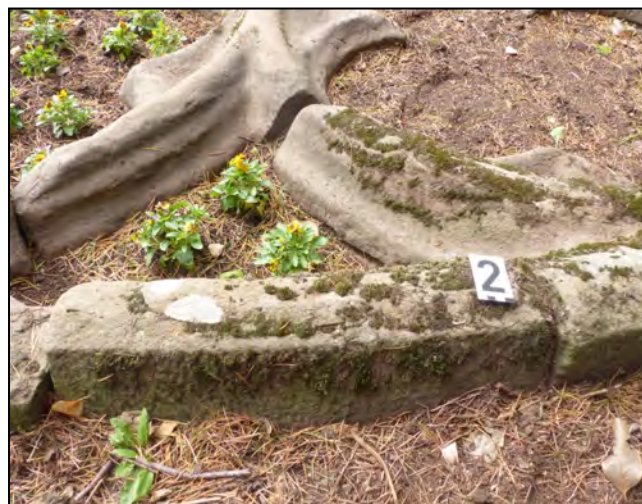
Date: 25/09/21	Stone #: BP 2-2 SUAT cross reference # 2	Recorded by: CS CD
Site: Balgay Park	Photo # 5-8,10

Damage: Delamination top surface, moss

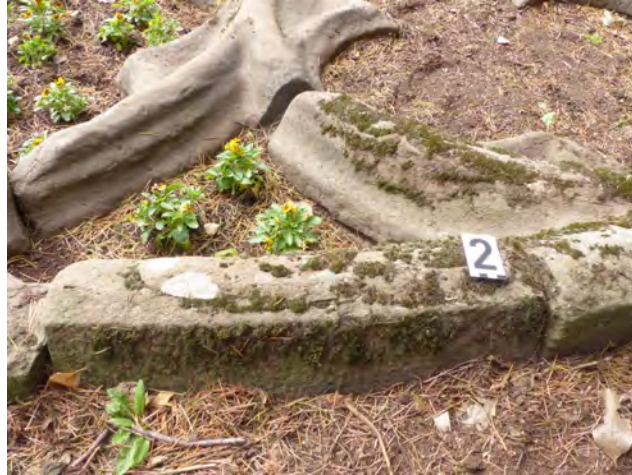
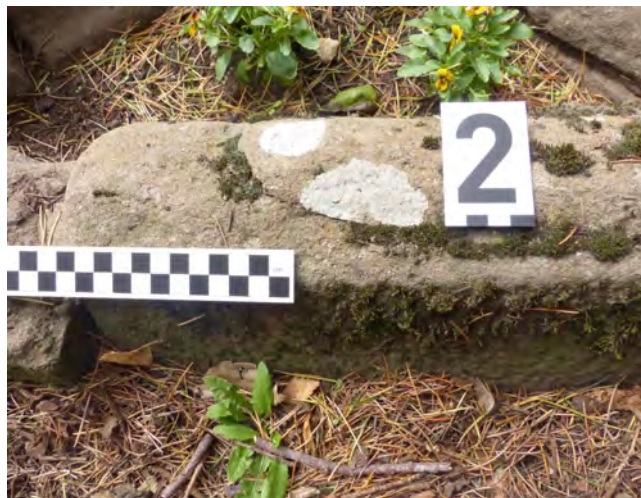
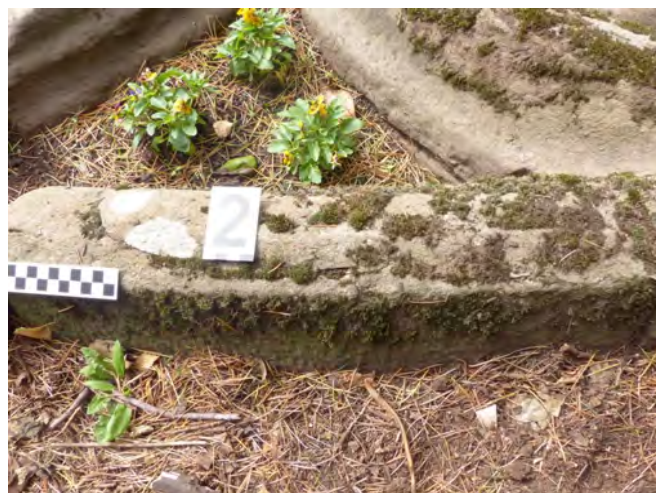
Date: 25/09/21	Stone #: BP 2-2 SUAT cross reference # 2	Recorded by: CS CD
Site: Balgay Park	Photo # 5-8,10

Damage: Delamination top surface, moss

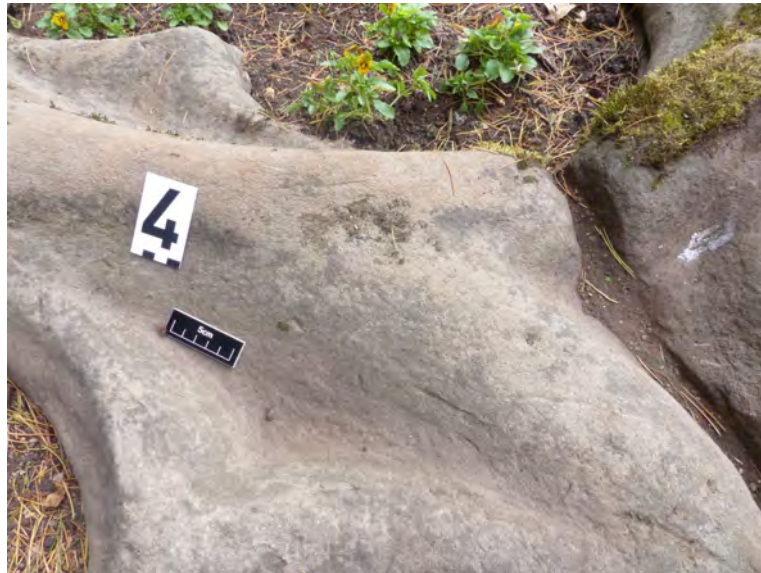
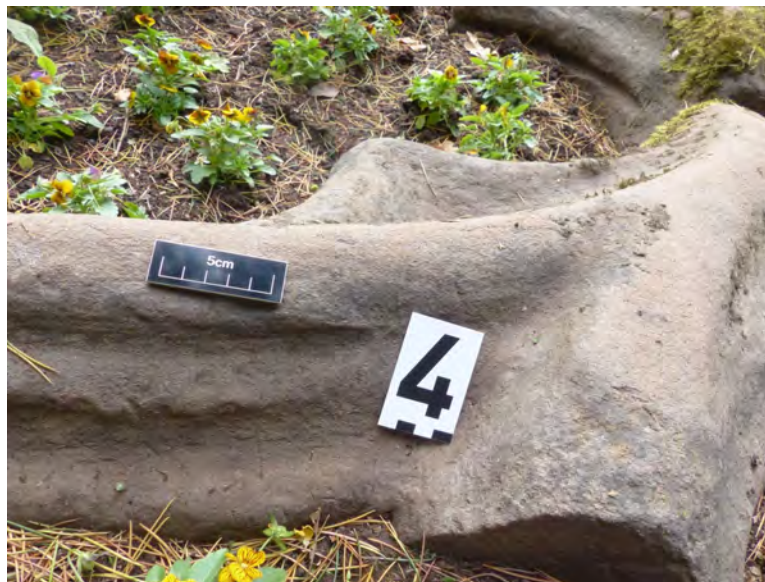
Date: 29/09/2021	Stone #: BP 2-4 SUAT cross reference # 4 Location 2	Recorded by: CS CD
Site: Balgay Park	Photo # 18-26

Damage: Strike marks –tool marks, possible chisel marks

Moss

Abraded cuts

Wear, closest to #3, west abutting

Recommendations: Do not use metal tools for gardening

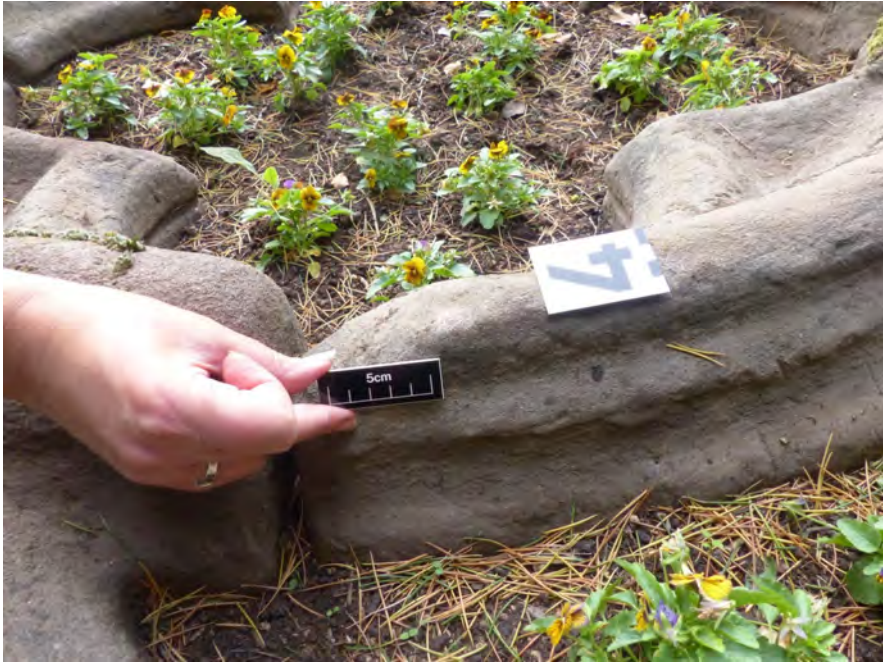
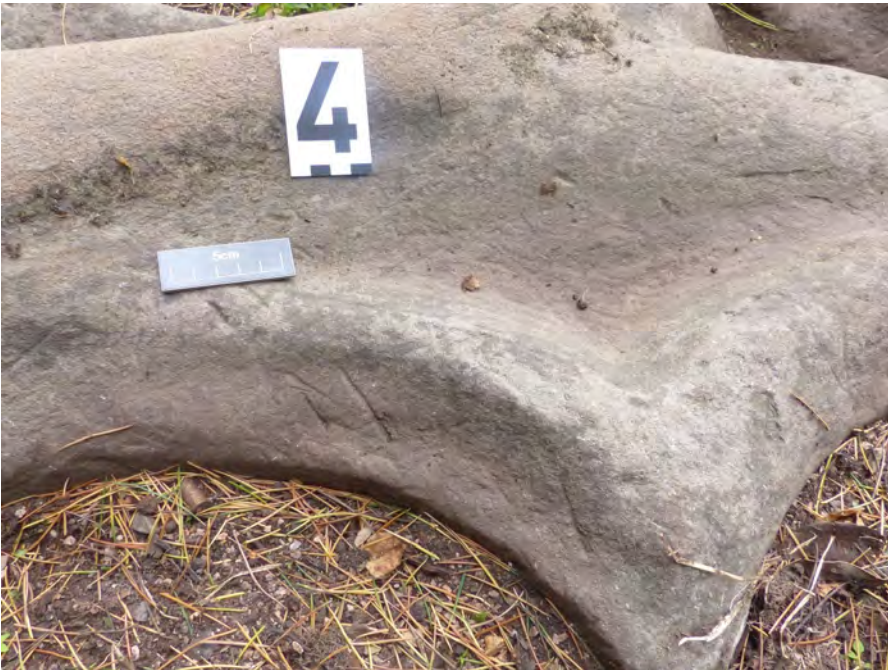
Date: 29/09/2021	Stone #: BP 2-4 SUAT cross reference # 4 Location 2	Recorded by: CS CD
Site: Balgay Park	Photo # 18-26	
<div data-bbox="354 407 1241 1066">

</div>		
<p>Damage: Strike marks –tool marks, possible chisel marks Moss Abraided cuts Wear,closest to #3, west abutting</p> <p>Recommendations: Do not use metal tools for gardening</p>

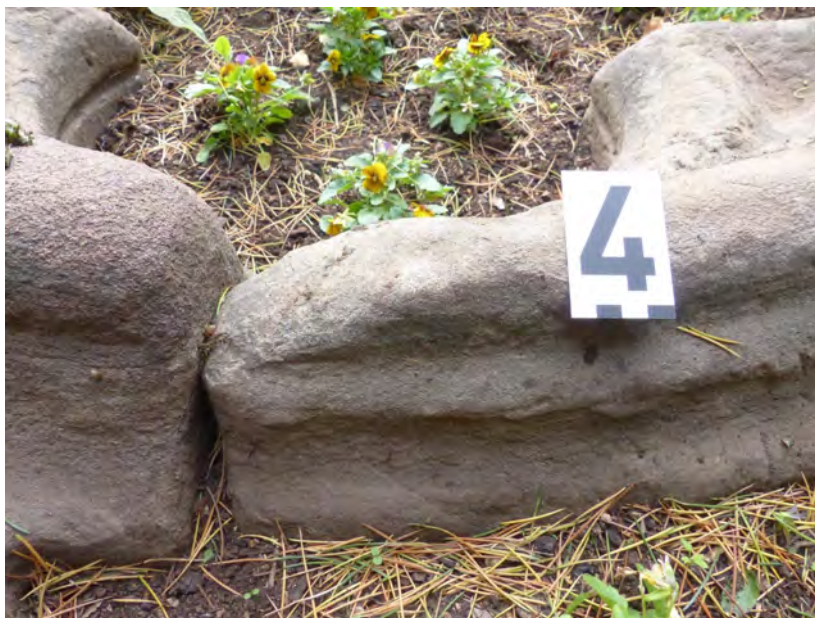
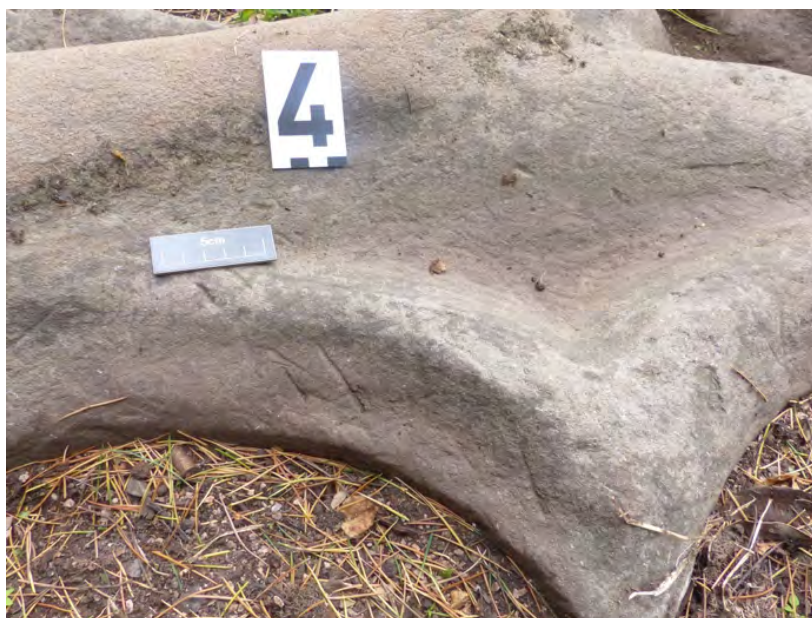
Date: 29/09/2021	Stone #: BP 2-4 SUAT cross reference # 4 Location 2	Recorded by: CS CD
Site: Balgay Park	Photo # 18-26

Damage: Strike marks –tool marks, possible chisel marks

Moss

Abraided cuts

Wear, closest to #3, west abutting

Recommendations: Do not use metal tools for gardening

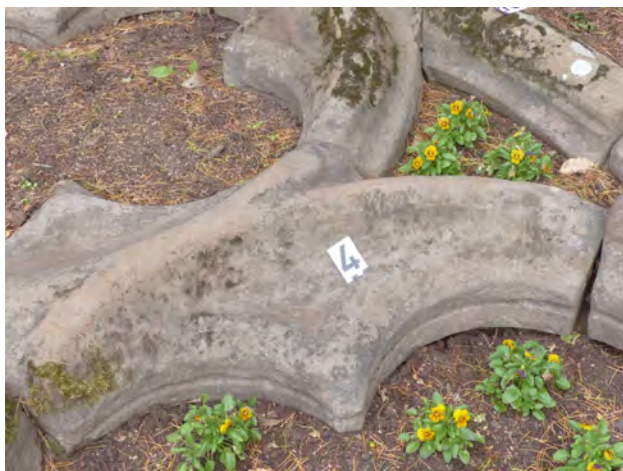
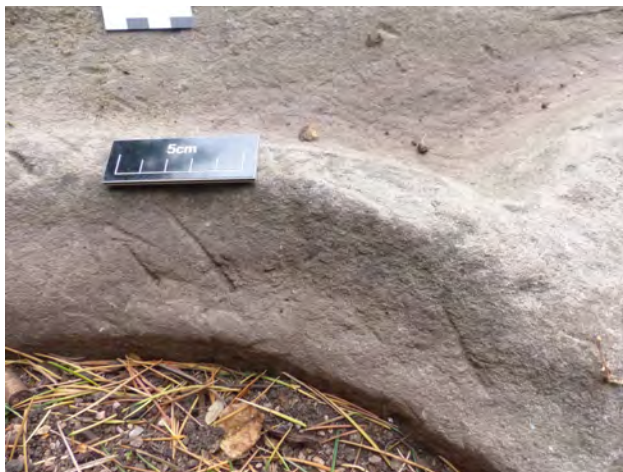
Date: 29/09/2021	Stone #: BP 2-4 SUAT cross reference # 4 Location 2	Recorded by: CS CD
Site: Balgay Park	Photo # 18-26

Damage: Strike marks – tool marks, possible chisel marks

Moss

Wear, closest to #3, west abutting

Recommendations: Do not use metal tools for gardening

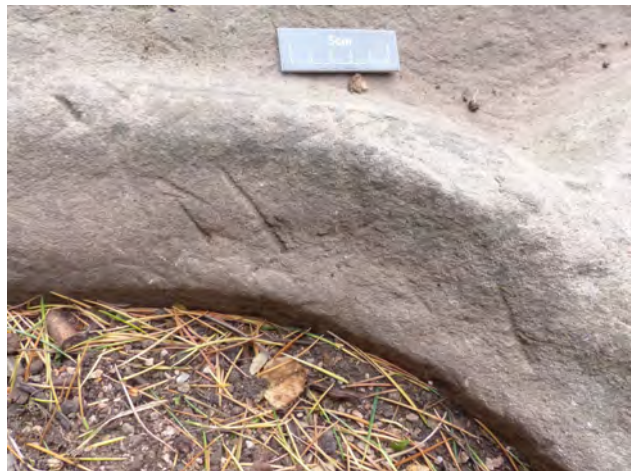
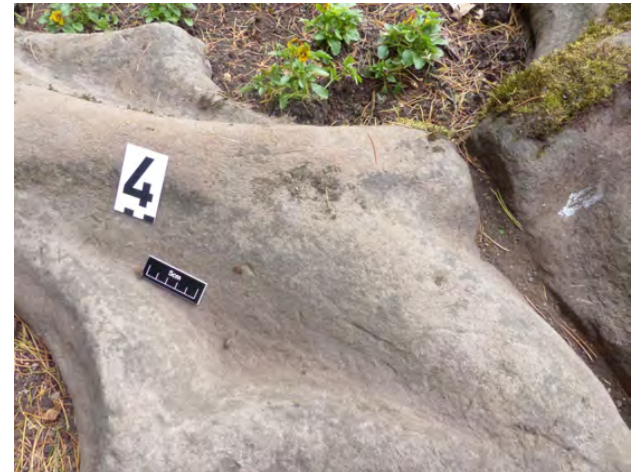
Abraided cuts

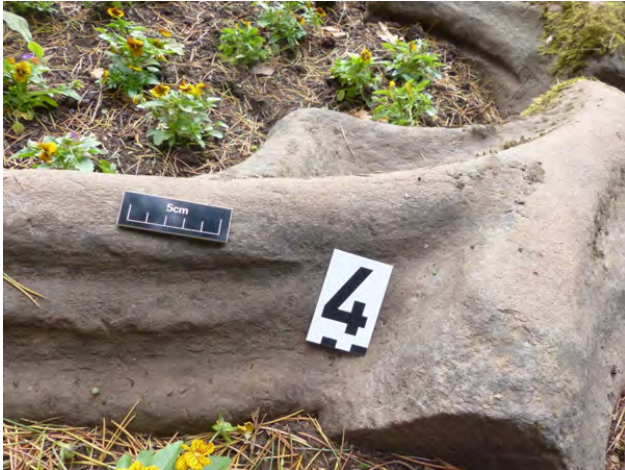
Date: 29/09/2021	Stone #: BP 2-4 SUAT cross reference # 4 Location 2	Recorded by: CS CD
Site: Balgay Park	Photo # 18-26

Damage: Strike marks –tool marks, possible chisel marks

Moss

Wear, closest to #3, west abutting

Recommendations: Do not use metal tools for gardening

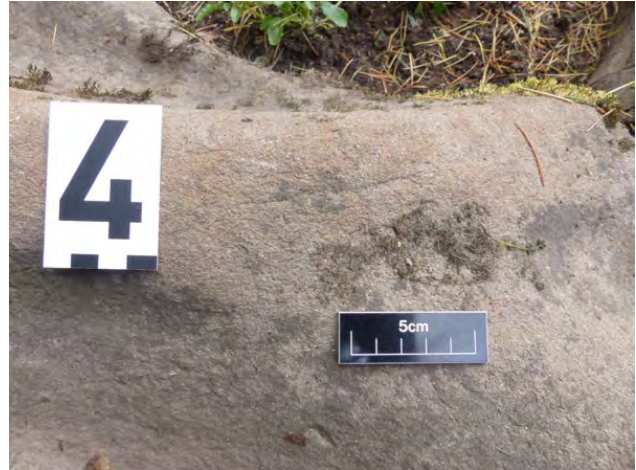
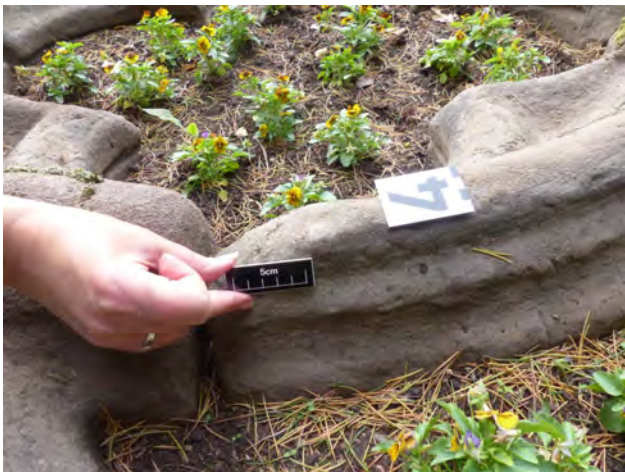
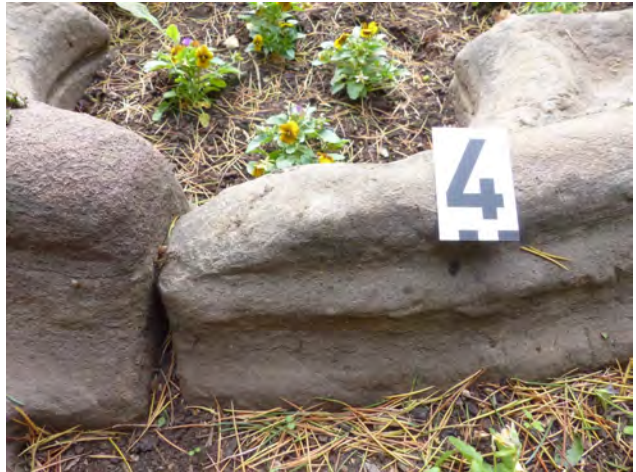
Abraided cuts

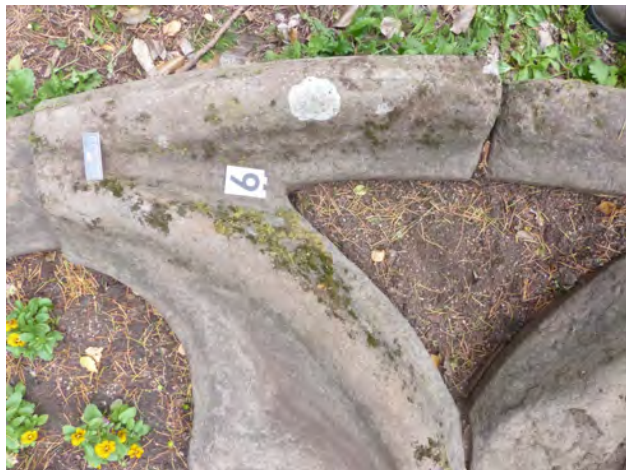
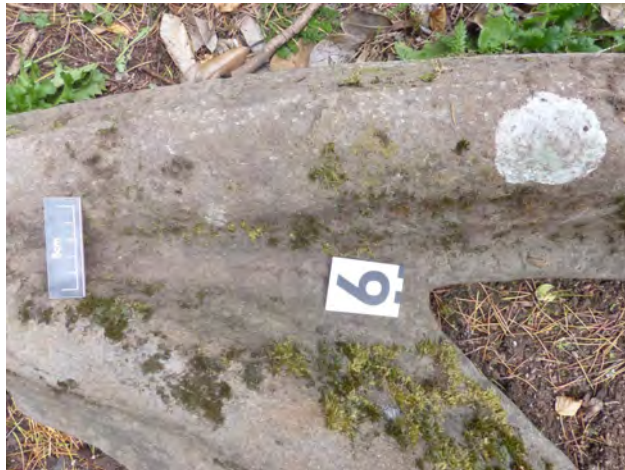
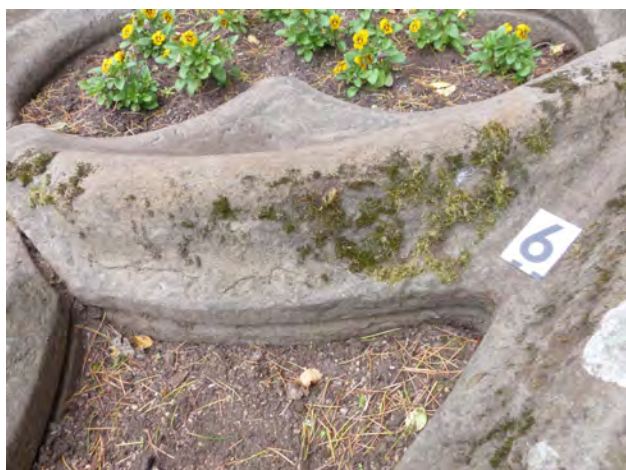
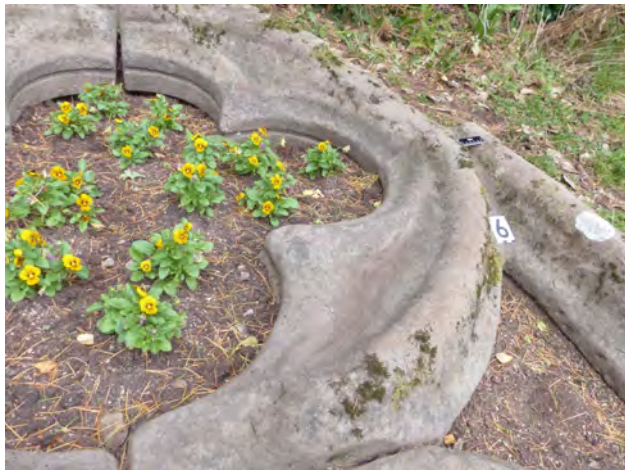
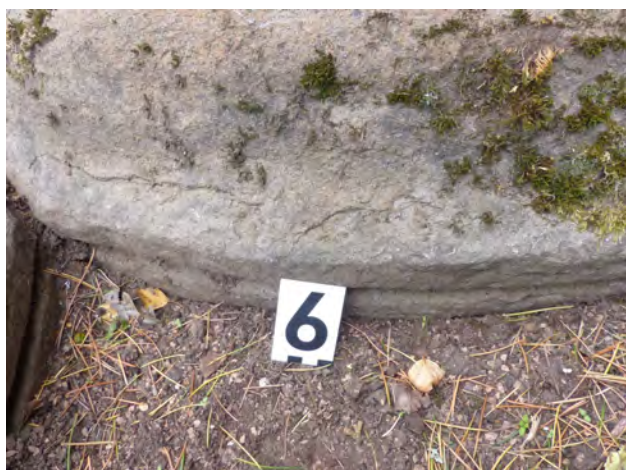
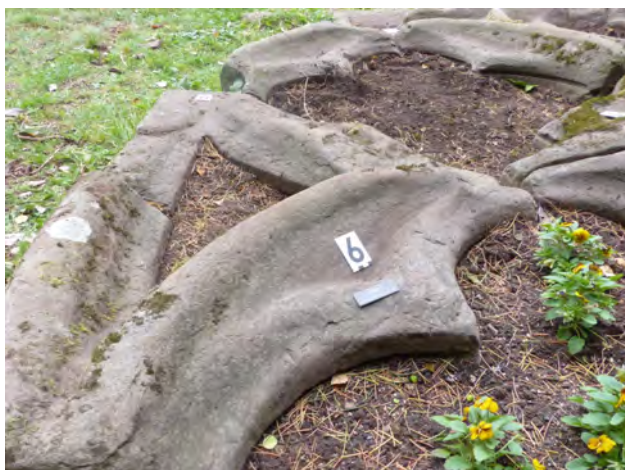
Date: 29/09/2021	Stone #: BP 2-6 SUAT cross reference # 6 Location 2	Recorded by: CS CD
Site: Balgay Park	Photo # 33-41

Damage: Moss, spalling in interior, delamination.
Tool marks (historic)
Tool marks (recent)

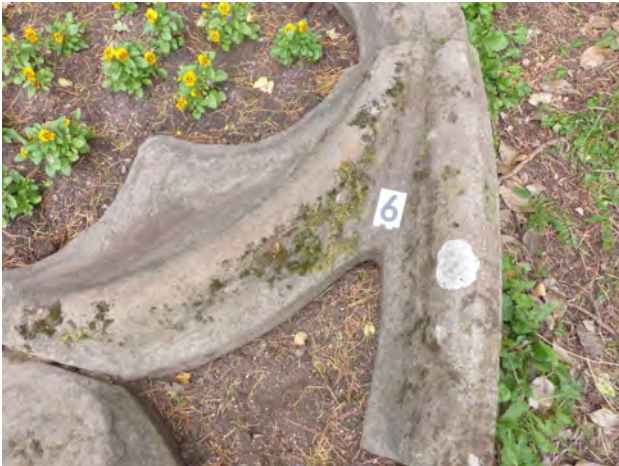
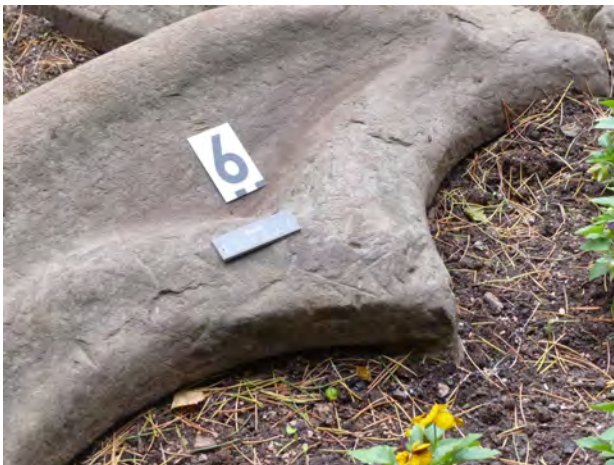
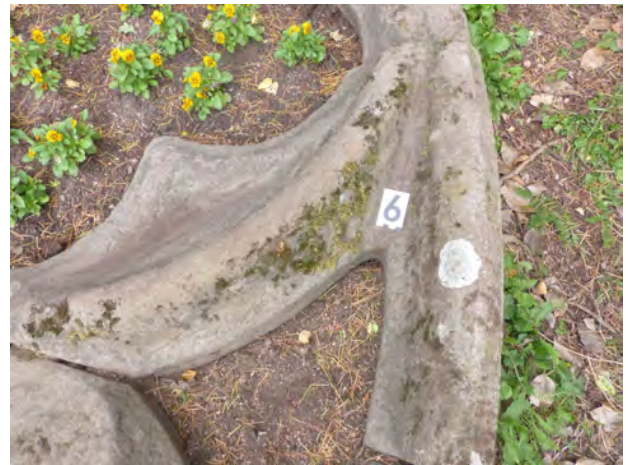
Date: 29/09/2021	Stone #: BP 2-6	Recorded by:
	SUAT cross reference # 6 Location 2	CS CD
Site: Balgay Park	Photo # 33-41

Damage: Moss, spalling in interior, delamination.

Tool marks (historic)

Tool marks (recent)

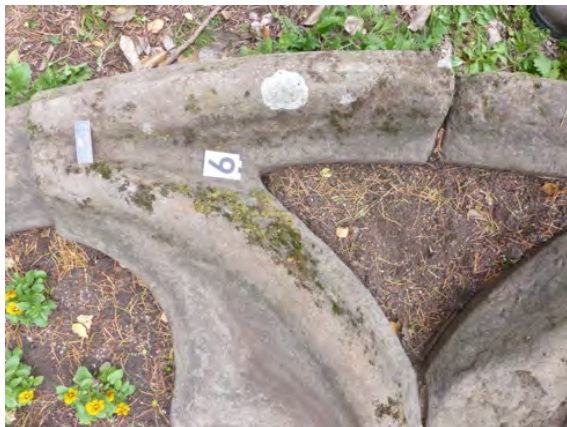
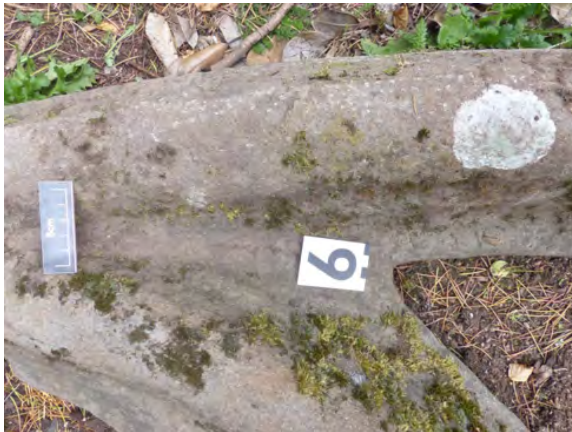
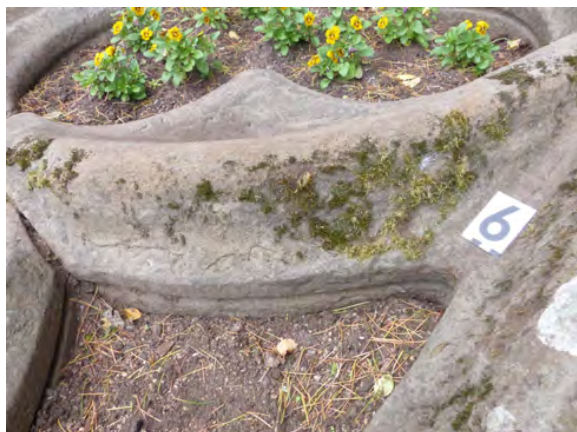
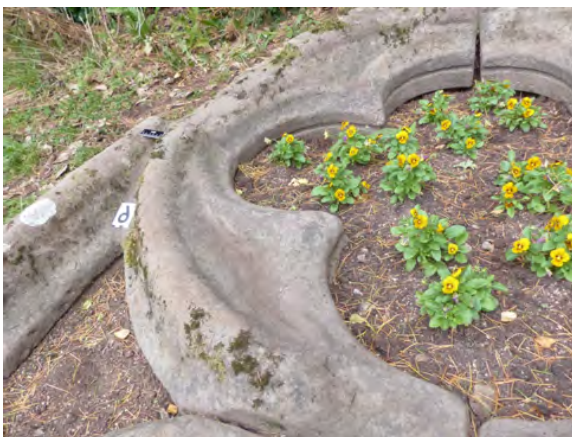
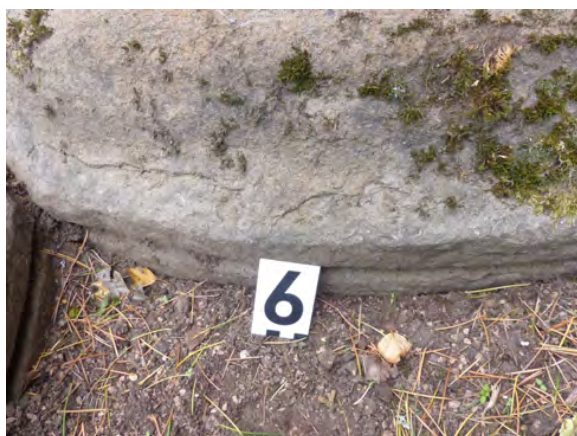
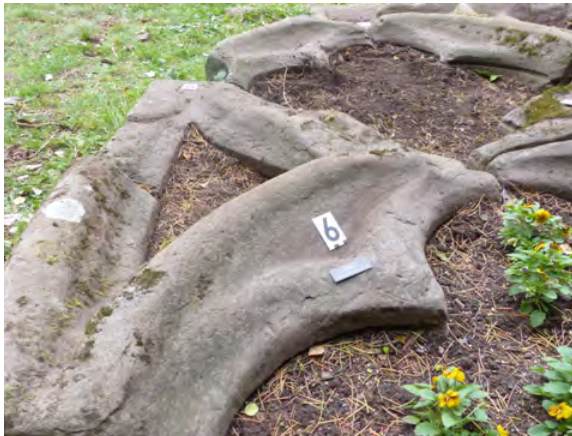
Date: 29/09/2021	Stone #: BP 2-6 SUAT cross reference # 6 Location 2	Recorded by: CS CD
Site: Balgay Park	Photo # 33-41

Damage: Moss, spalling in interior, delamination.
 Tool marks (historic)
 Tool marks (recent)

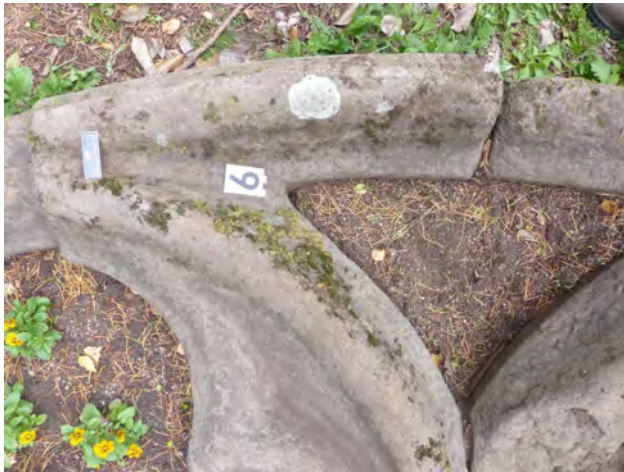
Date: 29/09/2021	Stone #: BP 2-6 SUAT cross reference # 6 Location 2	Recorded by: CS CD
Site: Balgay Park	Photo # 33-41

Damage: Moss, spalling in interior, delamination.
Tool marks (historic)
Tool marks (recent)

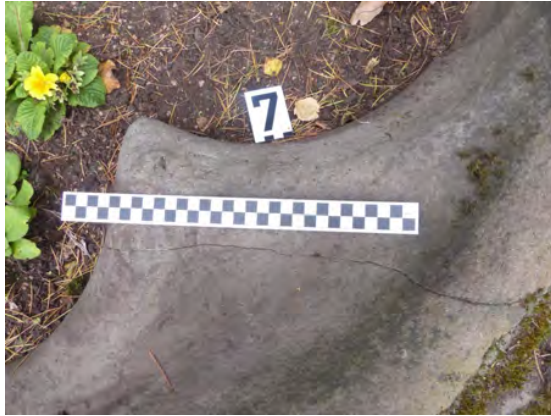
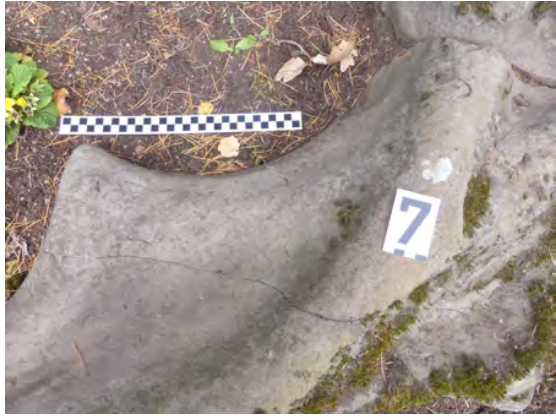
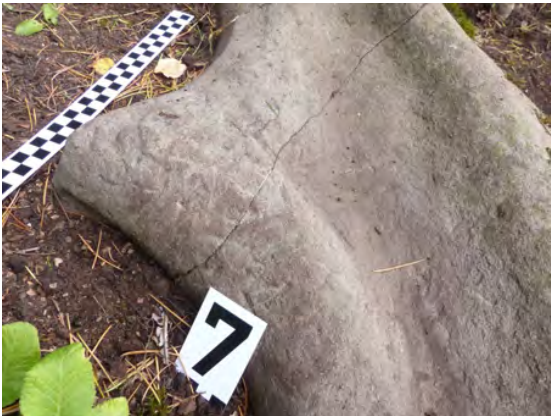
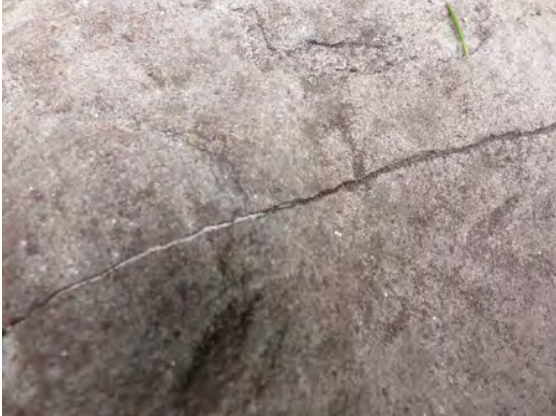
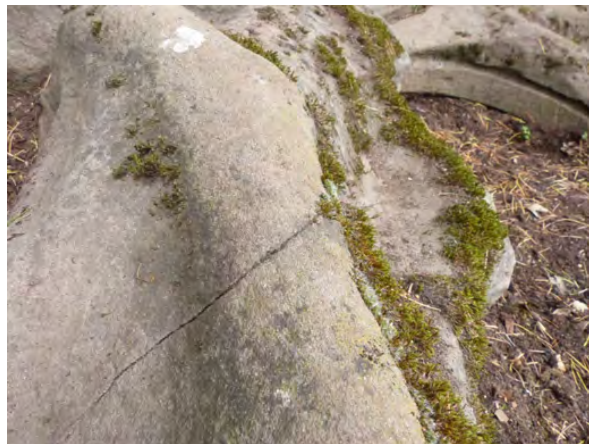
Date: 29/09/21	Stone #: BP 2-7 SUAT cross reference # 7 Location 2	Recorded by: CS CD
Site: Balgay Park	Photo #43-47

Damage:

Delamination

Crack (from frost) measured: 57 cm

Photo # 47 detail of crack

Loose stone has possibly moved

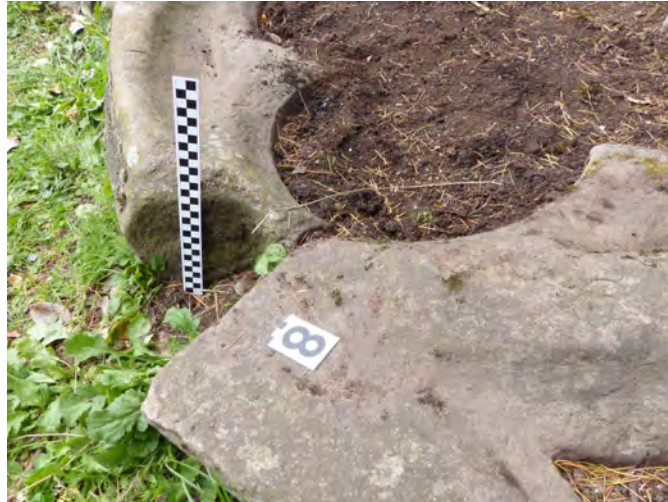
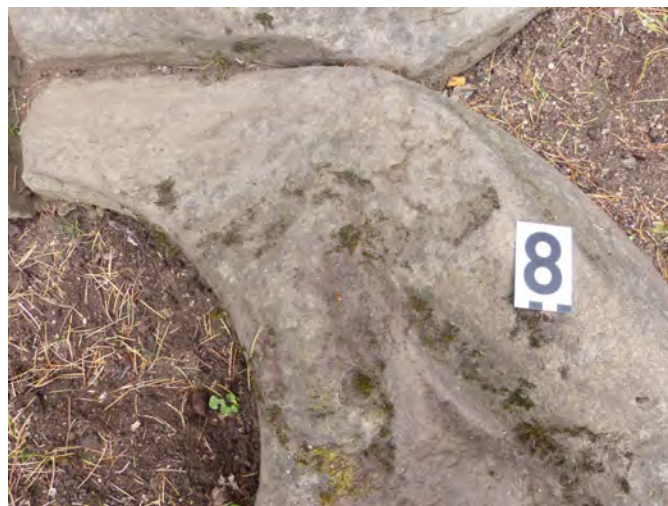
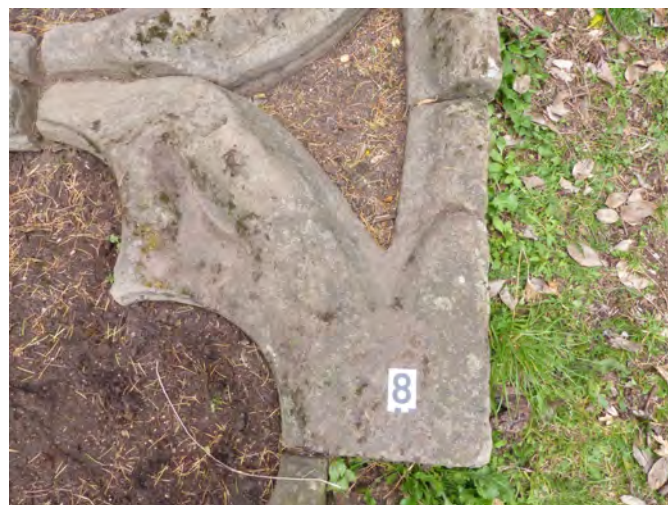
Date: 29/09/21	Stone #: BP 2-8 SUAT cross reference # 8 Location 2	Recorded by: CS CD
Site: Balgay Park	Photo # 48-50

2021 Water damage -historic

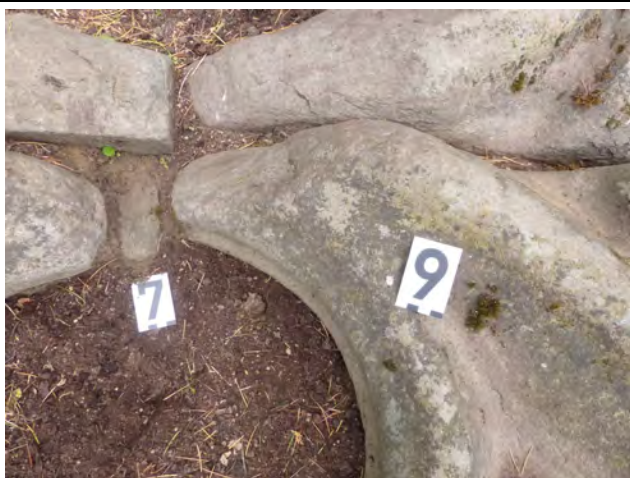
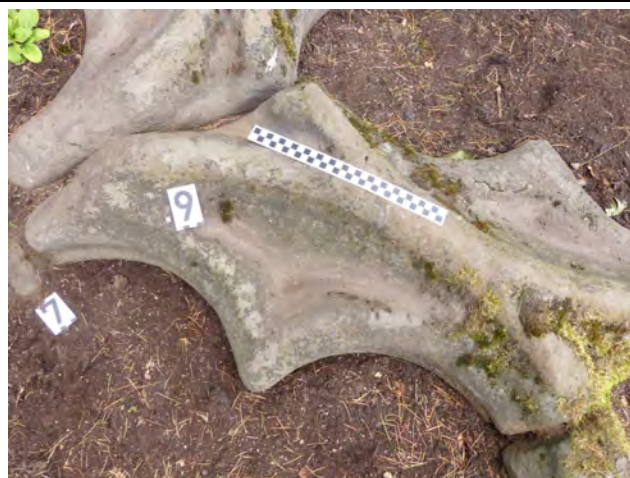
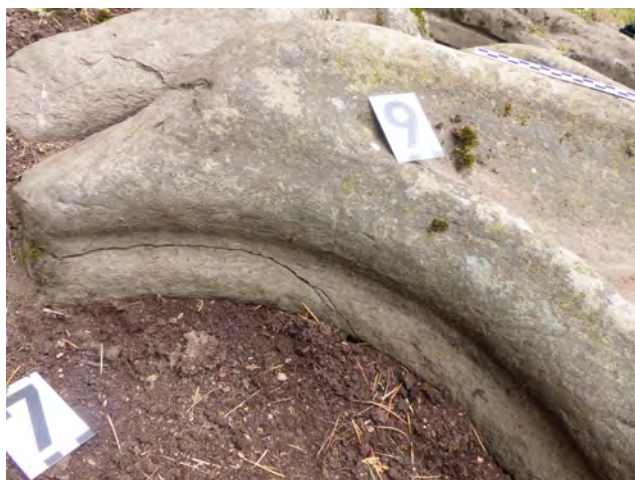
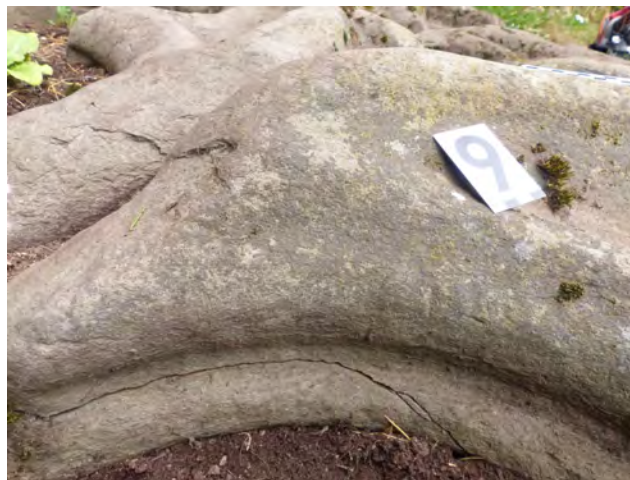
Date: 29/09/21	Stone #: BP 2-9 SUAT cross reference # 9 Location 2	Recorded by: CS CD
Site: Balgay Park	Photo # 51-54

Damage: 29/09/21 Crack: branching crack : 30 cm long
Smoothing
Water wear (surface loss)

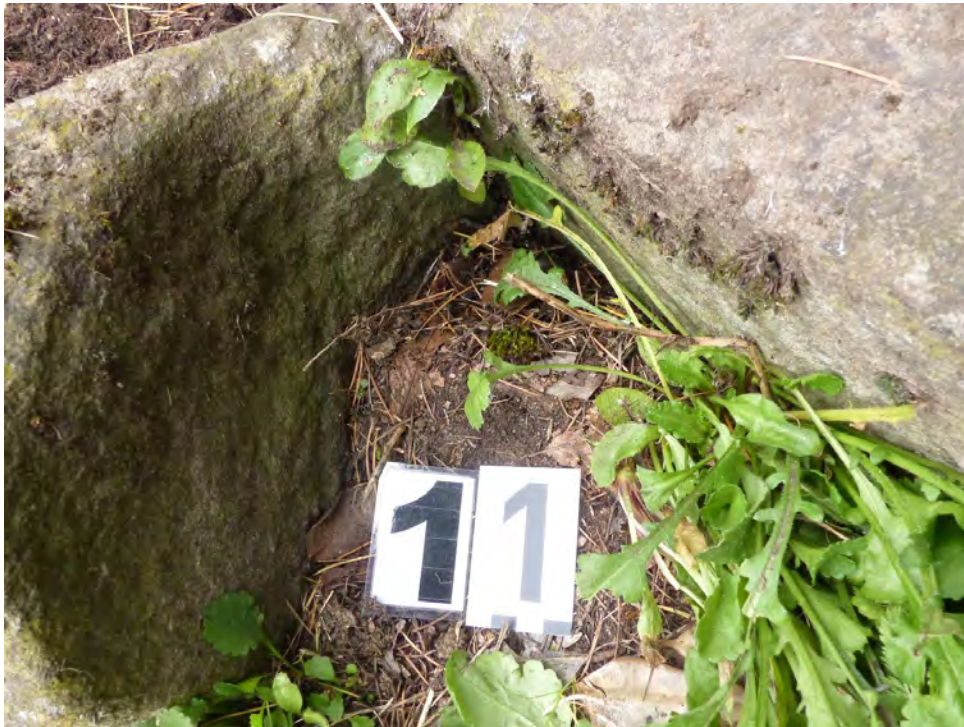
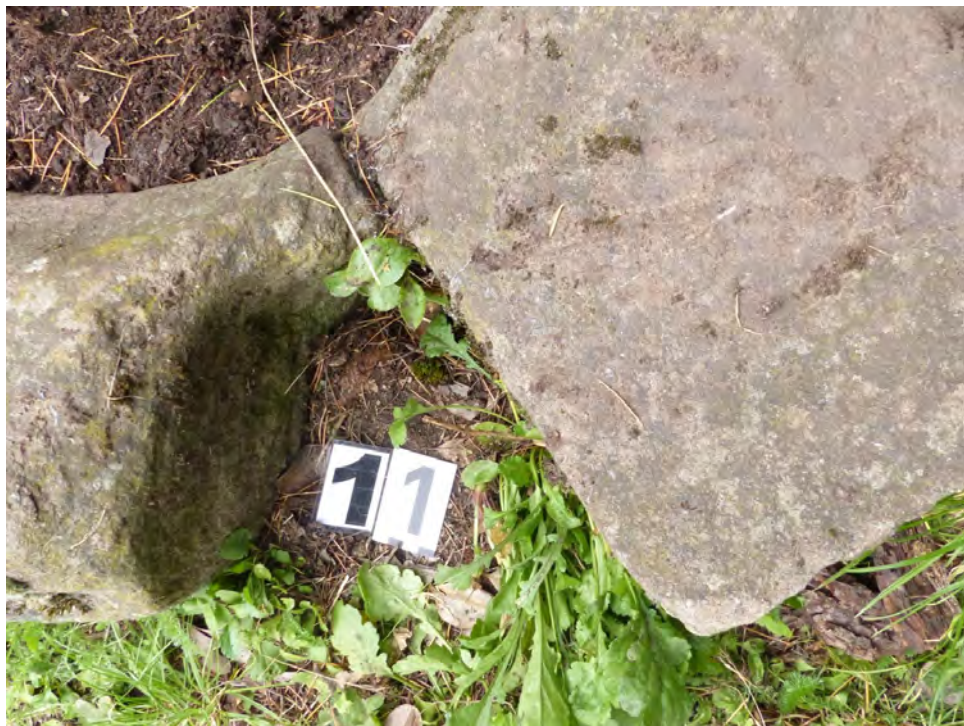
Date: 25/09/2021	Stone #: BP 2-11 SUAT cross reference # 11 Location 2	Recorded by: CS CD
Site: Balgay Park	Photo # 59, 60

Comments: Stone not present 25/09/2021
Photographs show gap.

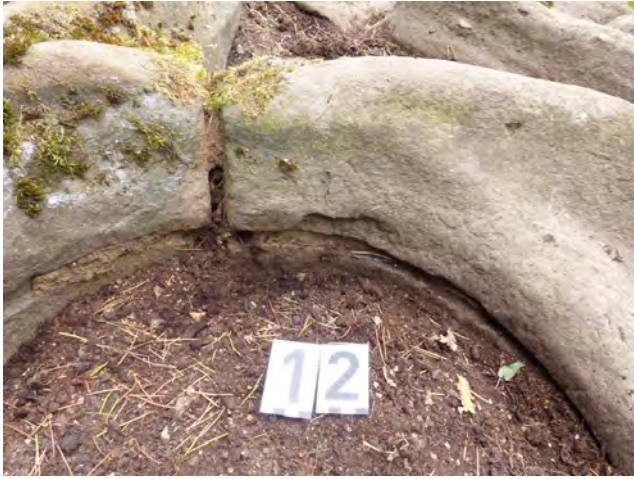
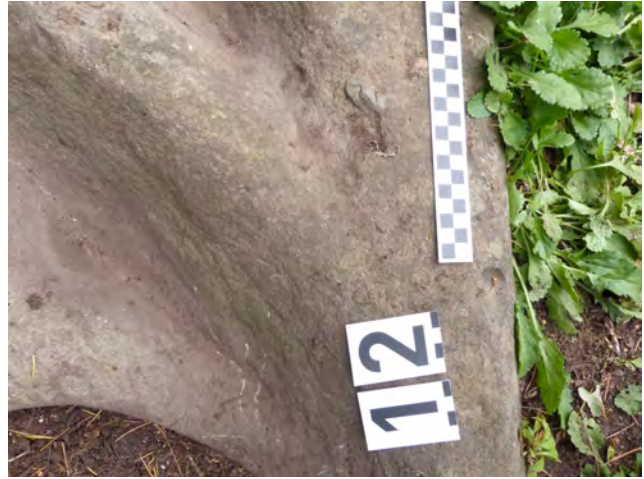
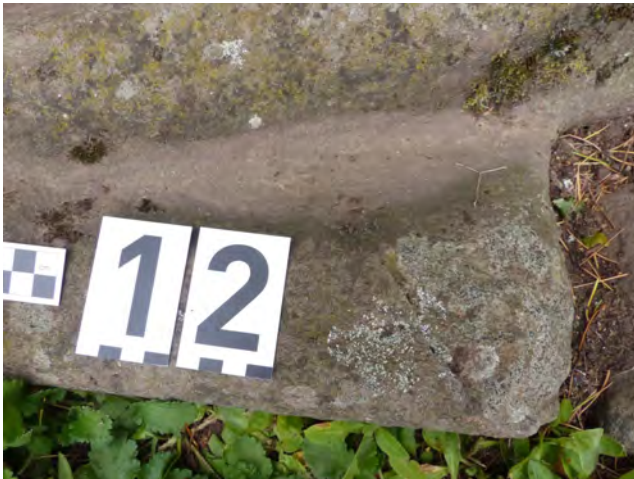
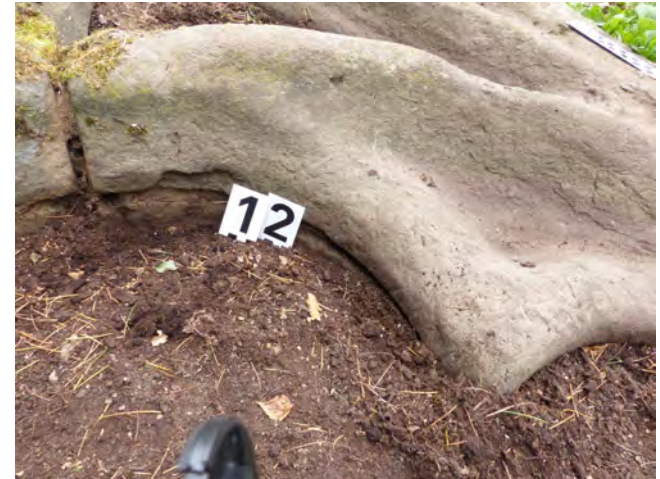
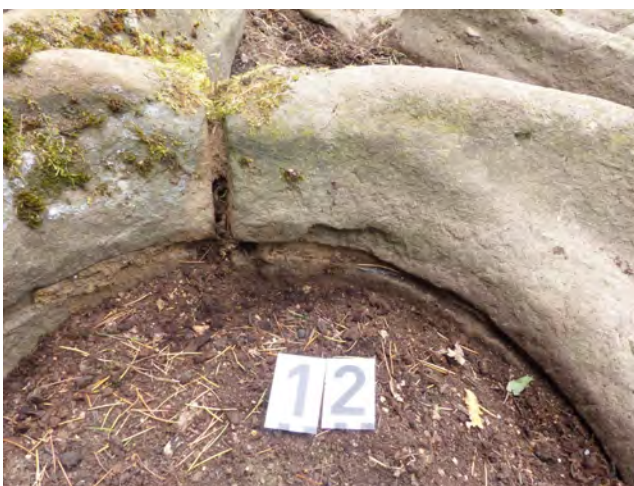
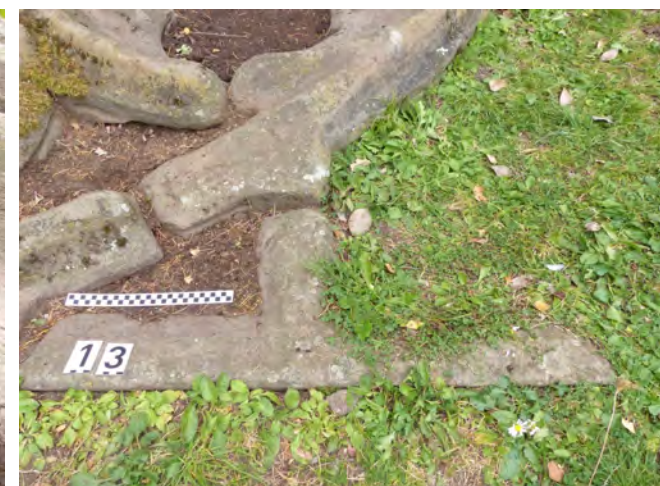
Date: 25/09/2021	Stone #: BP 2-12 SUAT cross reference # 12 Location 2	Recorded by: CS CD
Site: Balgay Park	Photo # 61-65

Damage:

Hard lichen –scraped off?

Moss

Shelf-piece missing. Overlain by lichen. New growth

Earth in recesses

Recommendations: More earth – build up to line of recesses
