Abertay Historical Society Fieldwork Division

Worked Stone Record

Stones from St Mary's Church in Balgay Park

Abertay Historical Society Field Division and Friends of Balgay recorded the stones in 2016 and undertook a condition check in 2021. The attached record sheets are from the 2021 condition.

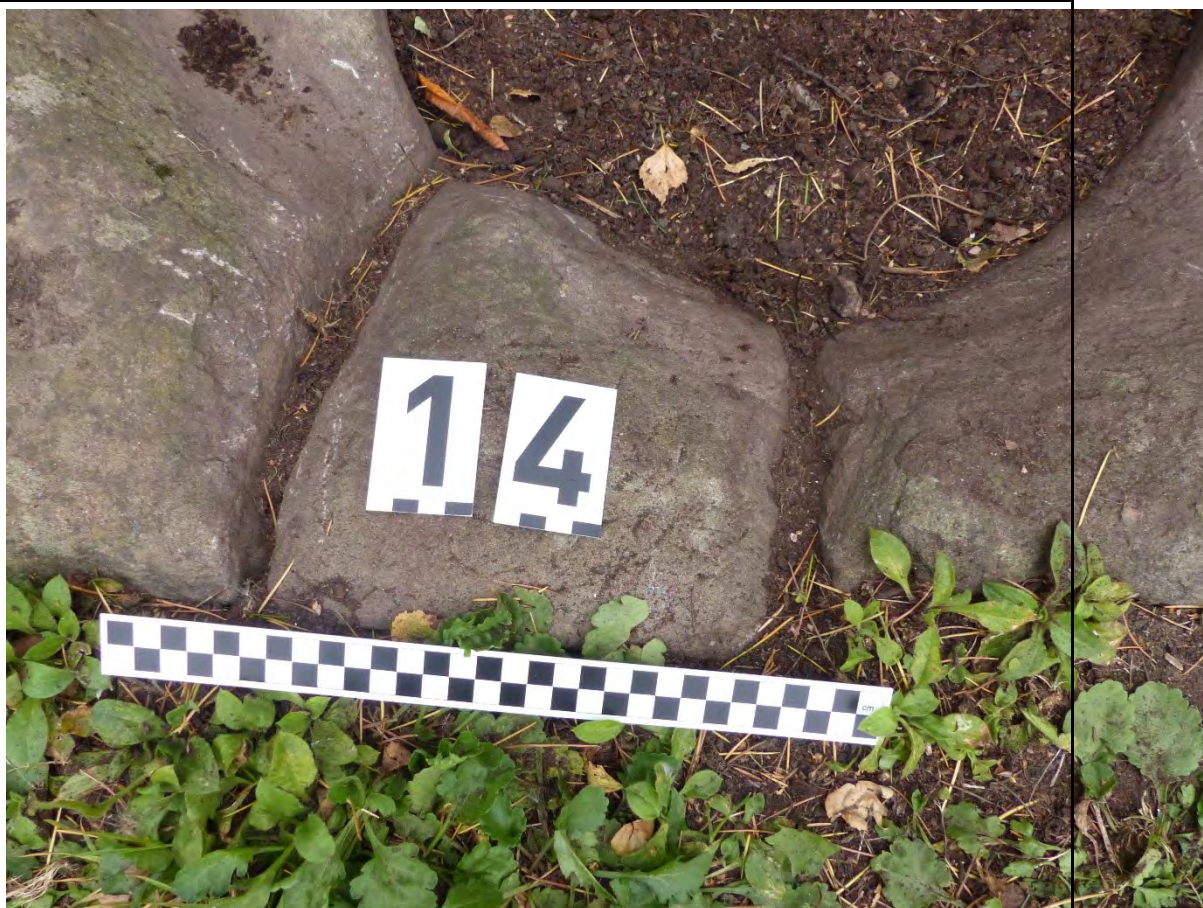
Date: 29/09/21	Stone #: BP 2-14 SUAT cross reference # 14 Location 2	Recorded by: CS CD
Site: Balgay Park	Photo #68

Comments:

Small stone, earthfast. Abraded
Recent scrapes (strimmer?)

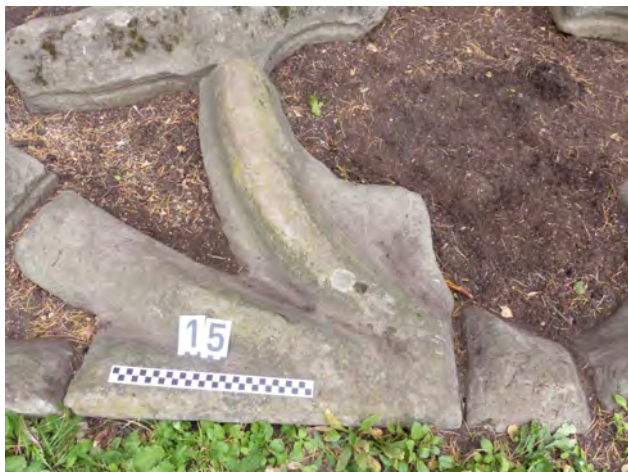
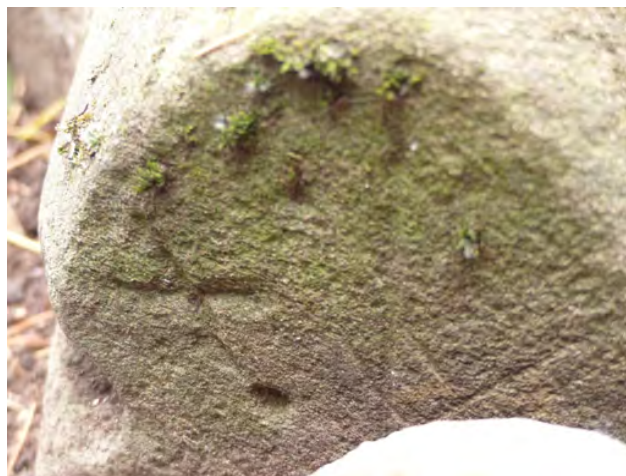
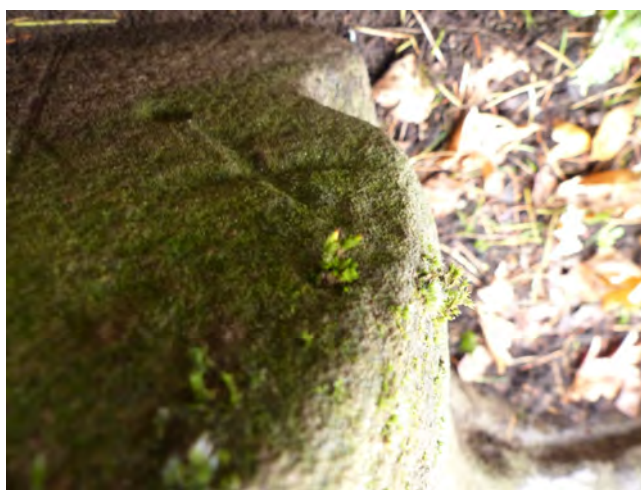
Date: 25/09/2021	Stone #: BP 2 SUAT cross reference # 15 Location 2	Recorded by: CS CD
Site: Balgay Park	Photos# 69-76

Historic water damage

Delamination

Recent damage – possibly from a strimmer?

Possible mason's mark on end of one stone

Recommendations: Avoid using metal tools, strimmer around stones

Moira Greig to be consulted re: mason's marks

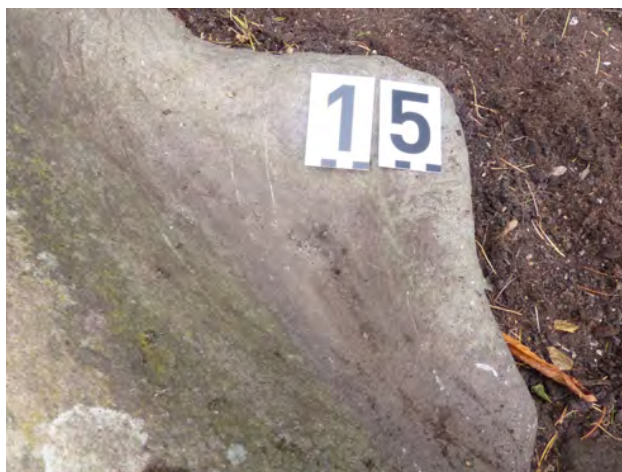
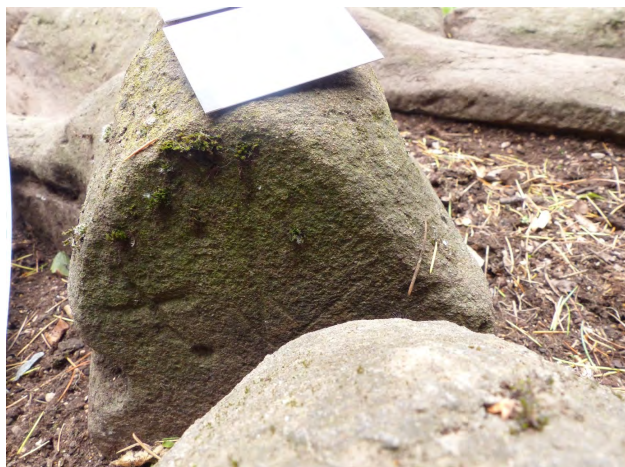
Comments:

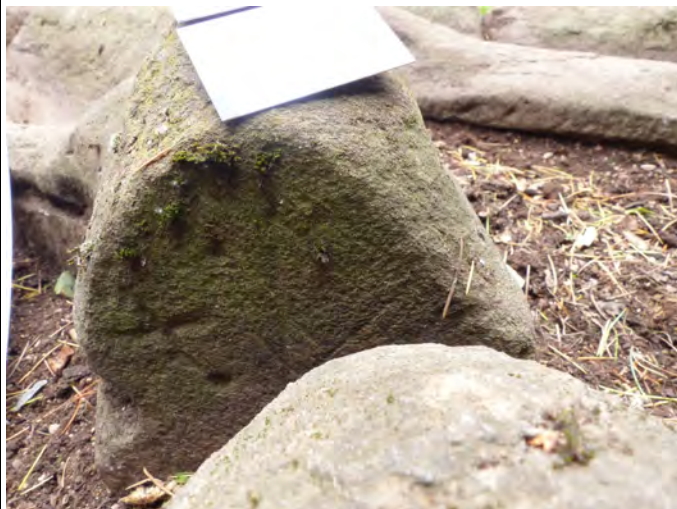
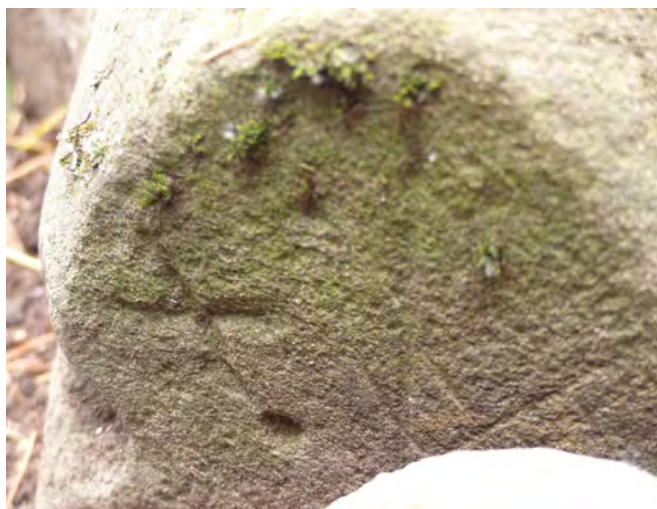
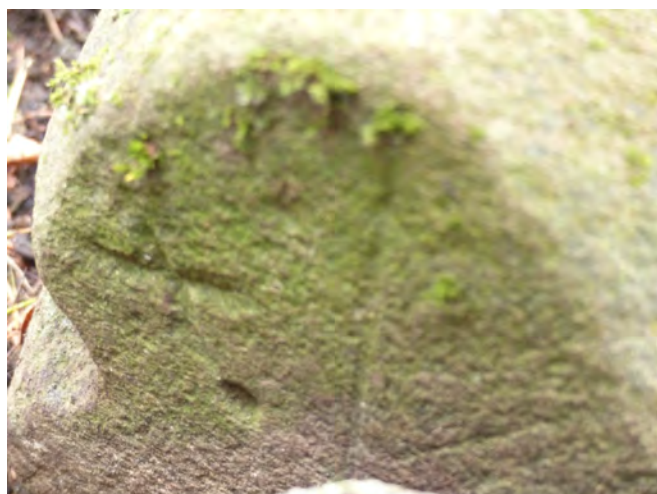
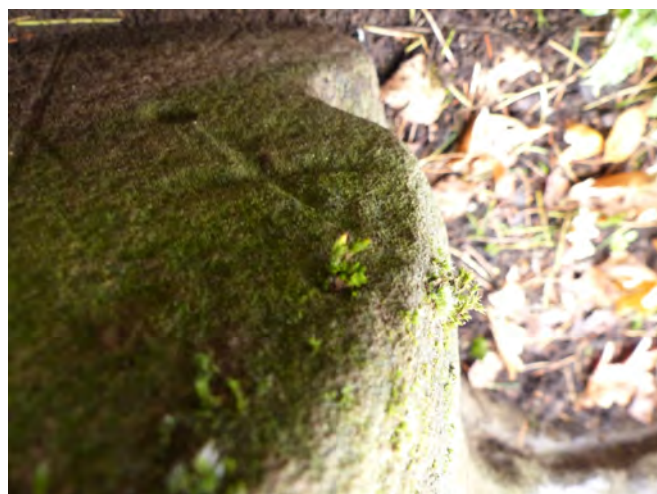
Date: 25/09/2021	Stone #: BP 2 SUAT cross reference # 15 Location 2	Recorded by: CS CD
Site: Balgay Park	Photos# 69-76

Historic water damage

Delamination

Recent damage – possibly from a strimmer?

Possible mason's mark on end of one stone

Recommendations: Avoid using metal tools, strimmer around stones

Moira Greig to be consulted re: mason's marks

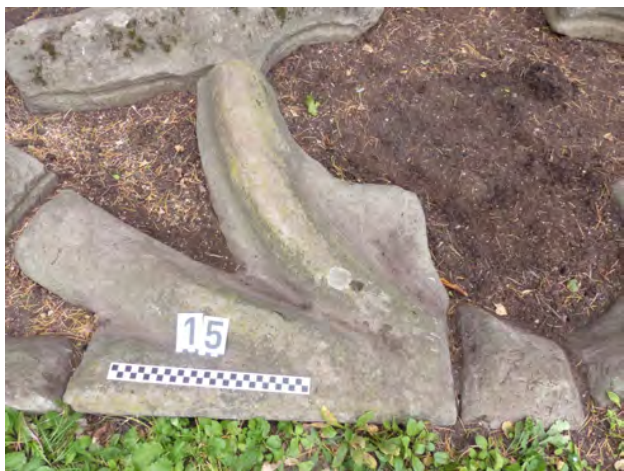
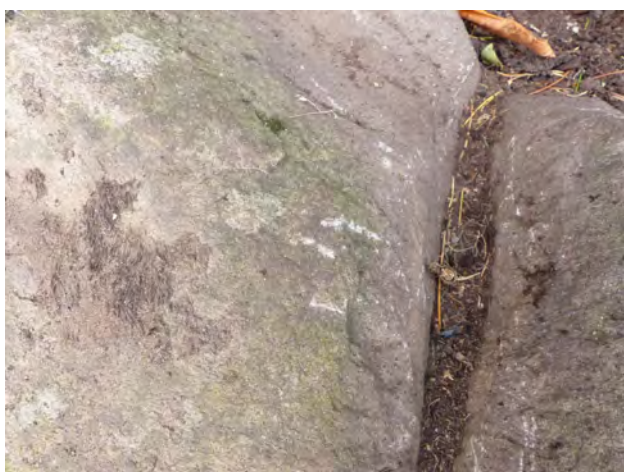
Date: 25/09/2021	Stone #: BP 2 SUAT cross reference # 15 Location 2	Recorded by: CS CD
Site: Balgay Park	Photos# 69-76

Historic water damage

Delamination

Recent damage – possibly from a strimmer?

Recommendations: Avoid using metal tools, strimmer around stones

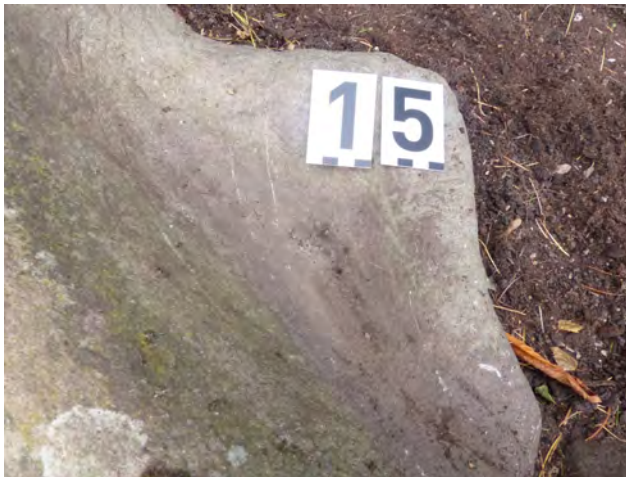
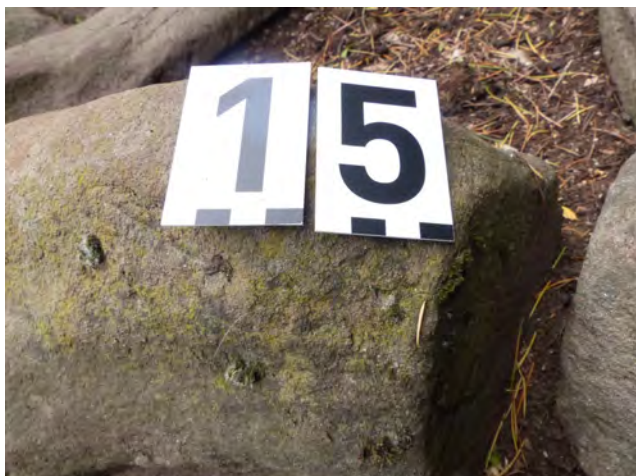
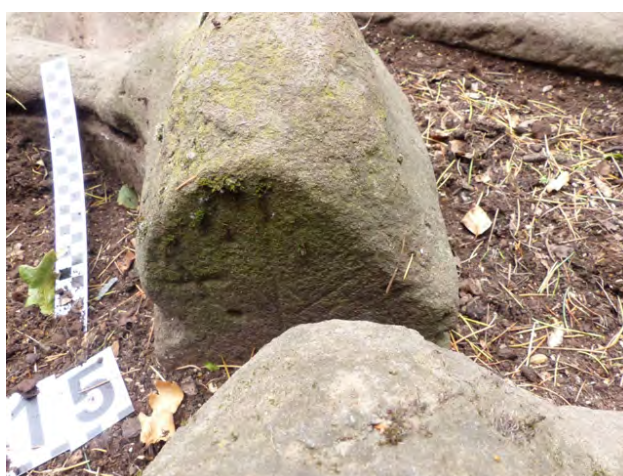
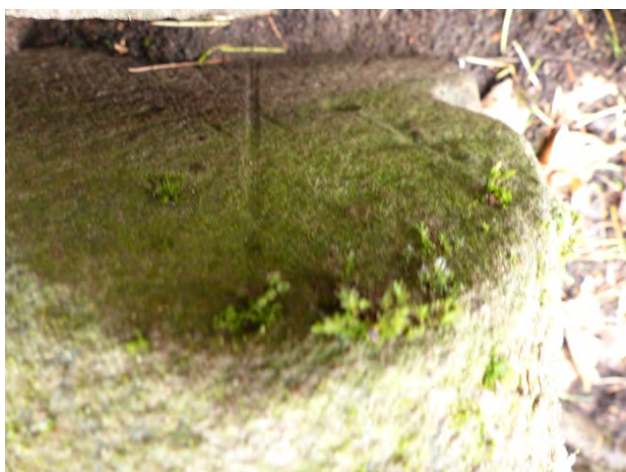
Possible mason's mark on end of one stone

Moira Greig to be consulted re: mason's marks

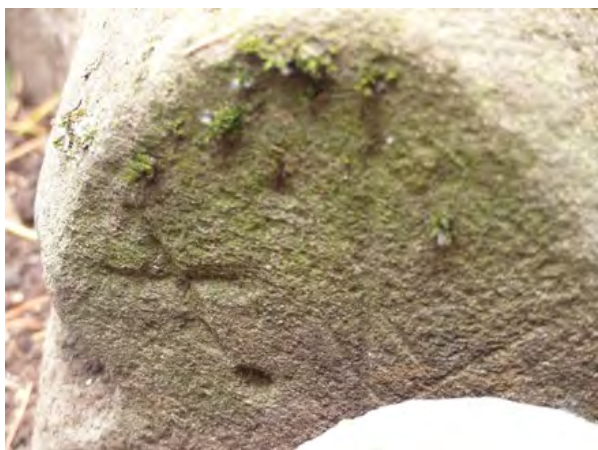
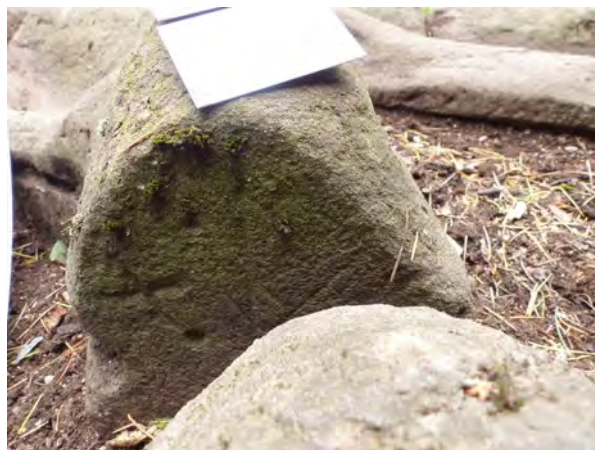
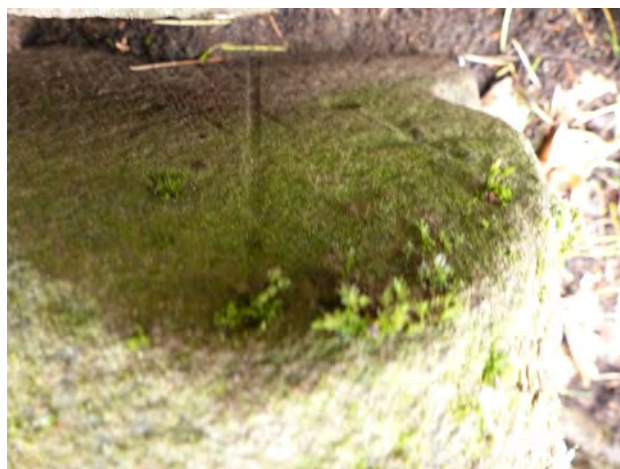
Date: 25/09/2021	Stone #: BP 2 SUAT cross reference # 15 Location 2	Recorded by: CS CD
Site: Balgay Park	Photos# 69-76

Comments:

Historic water damage

Recent damage – possibly from a strimmer?

Recommendations: Avoid using metal tools, strimmer around stones

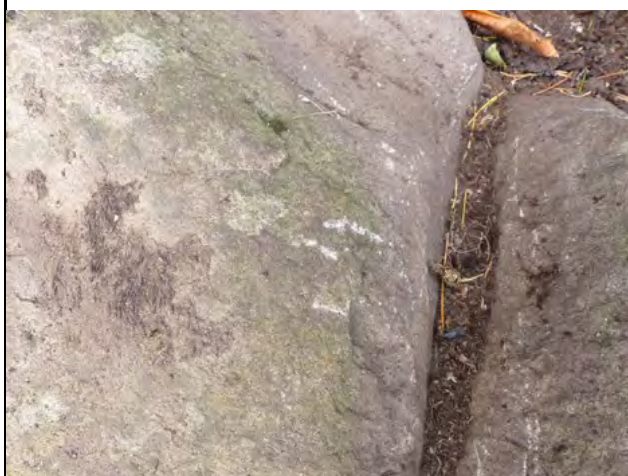
Delamination

Possible mason's mark on end of one stone

Moira Greig to be consulted re: mason's marks

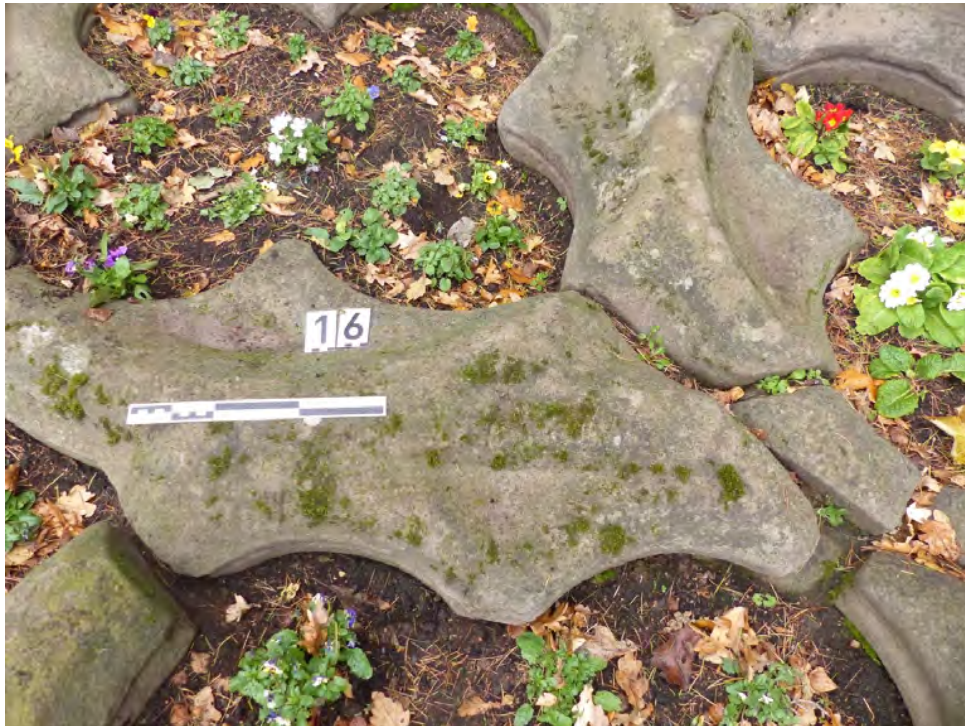
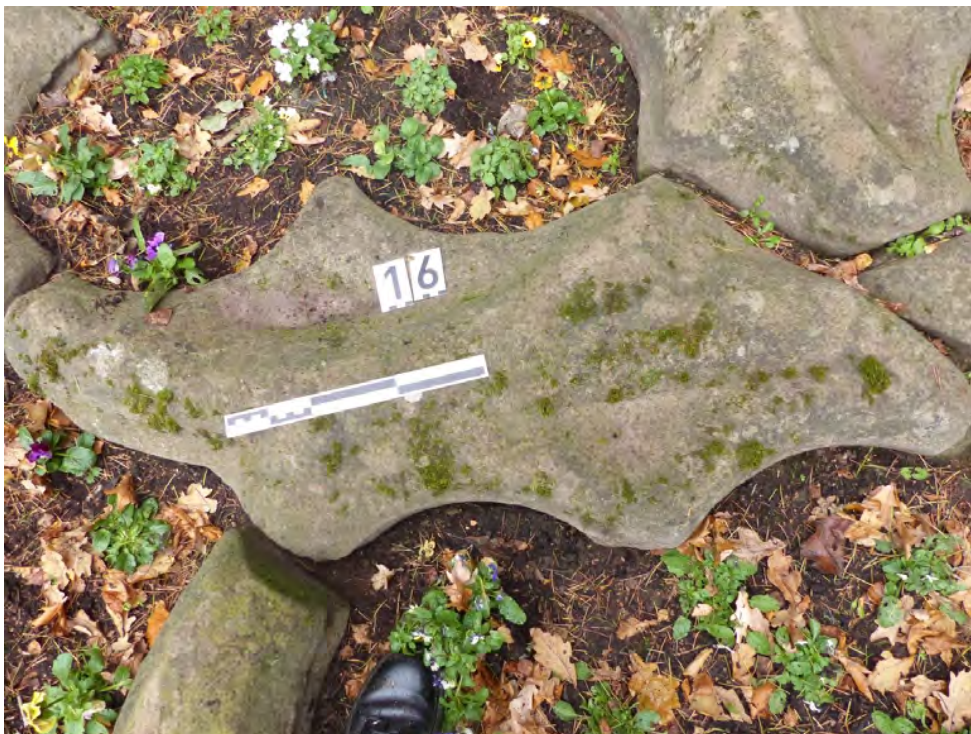
Date: 20/11/2021	Stone #: BP 2 16 SUAT cross reference # 16 Location 2	Recorded by: CS CD
Site: Balgay Park	Photos# 77,78

Damage:
West end eroded

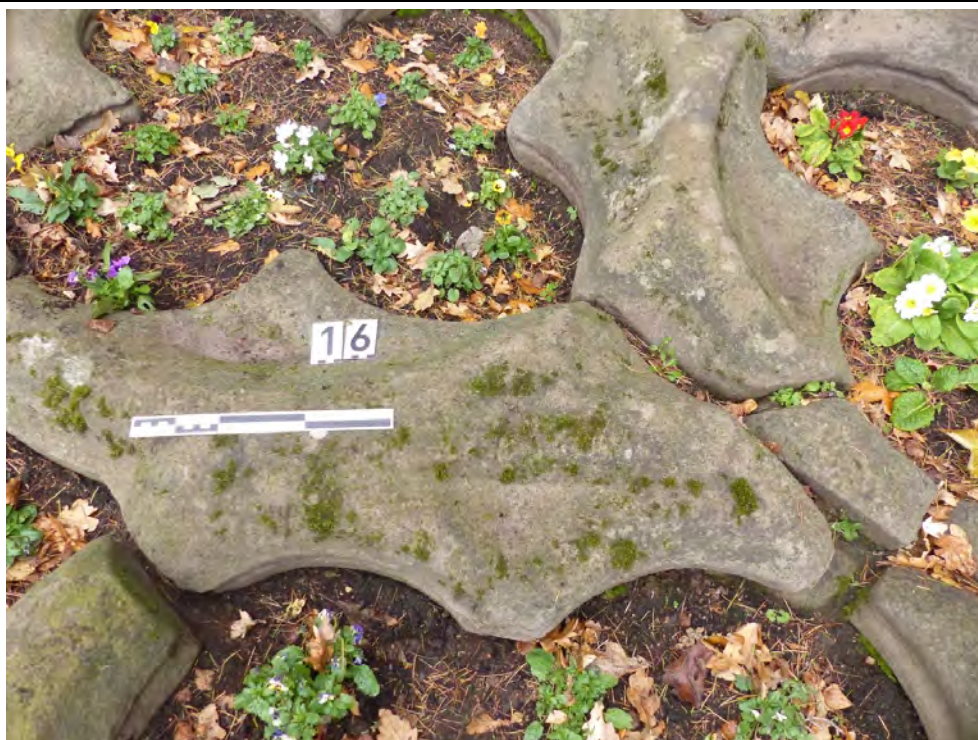
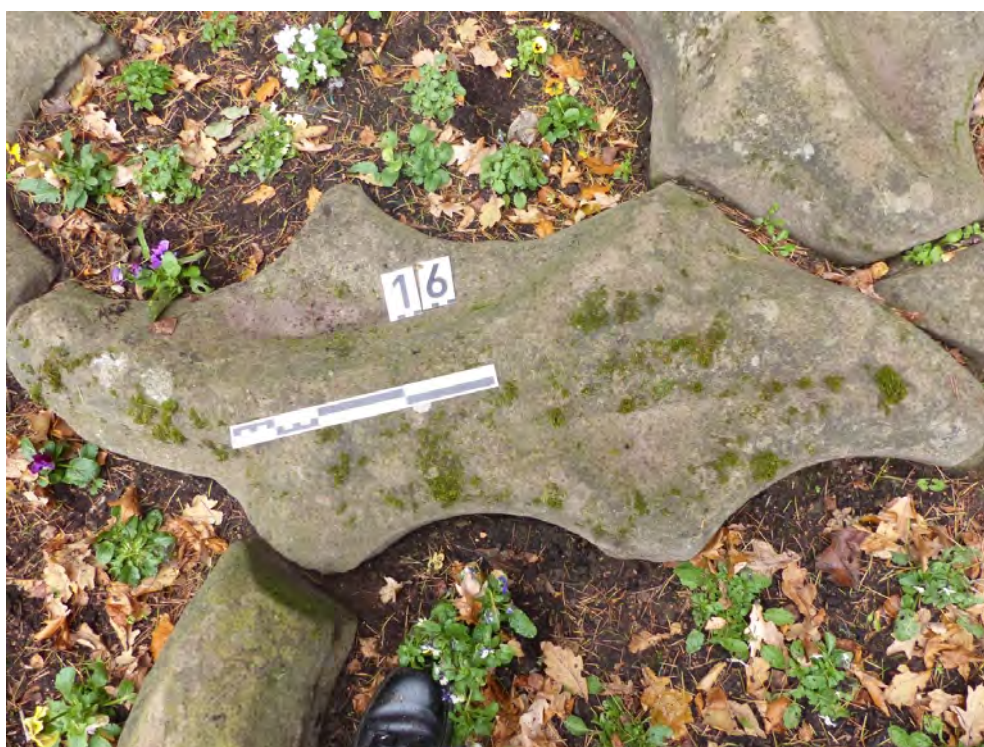
Date: 20/11/2021	Stone #: BP 2 16 SUAT cross reference # 16 Location 2	Recorded by: CS CD
Site: Balgay Park	Photos# 77,78

Damage:
West end eroded

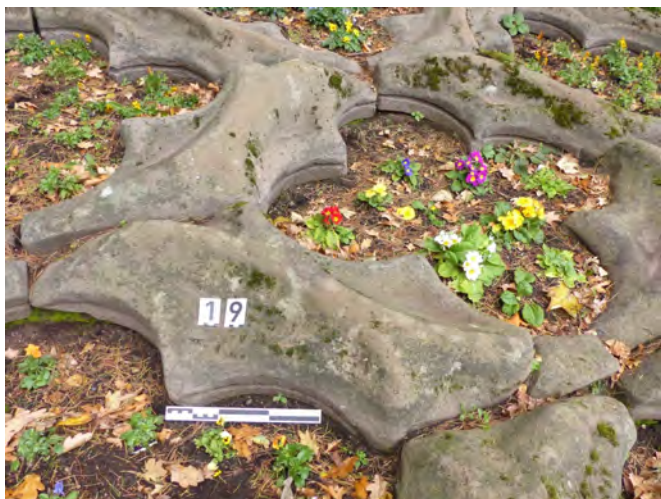
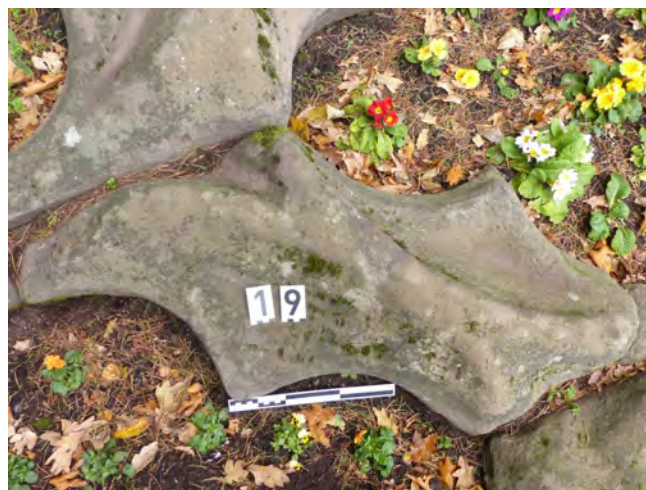
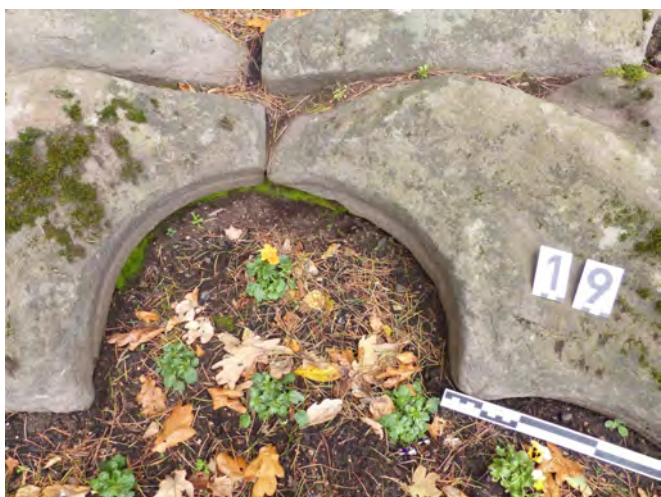
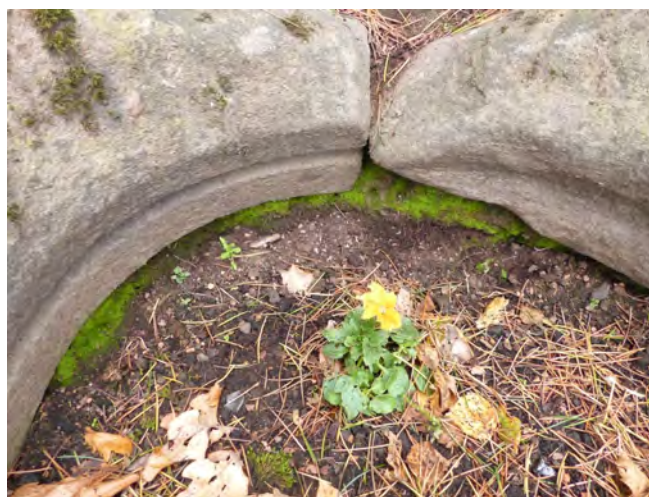
Date: 20/11/2021	Stone #: BP 2-19 SUAT cross reference # 19 Location 2	Recorded by: CS CD LT
Site: Balgay Park	Photos# 83-89

Damage: Moss on overhang

Delamination (historic)

Toolmarks (recent)

Crack with moss growing in 160 cm

Recommendations: Use non-metal tools while gardening

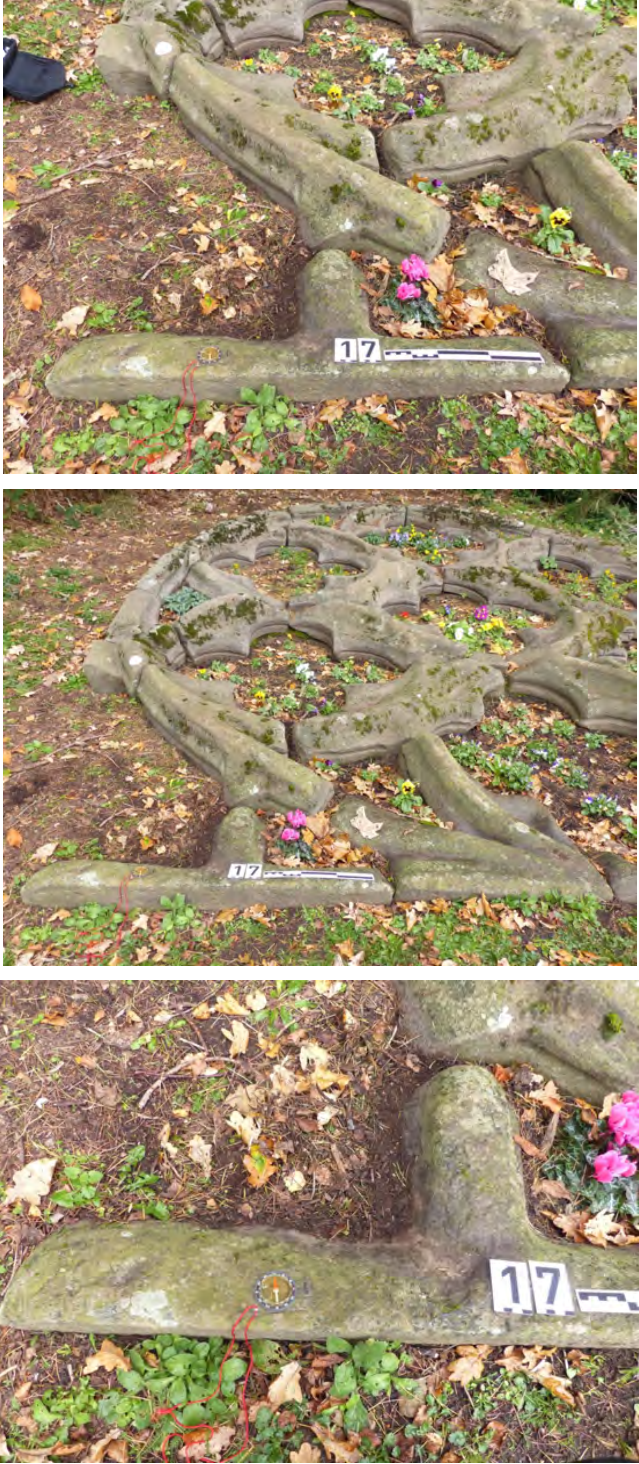
Date: 20/11/2021	Stone #: BP 2-17 SUAT cross reference # 17 Location 2	Recorded by: CS CD LT
Site: Balgay Park	Photos# 79-81

Comments: Fixing hole on sill/lintel base of stone. 10 mm

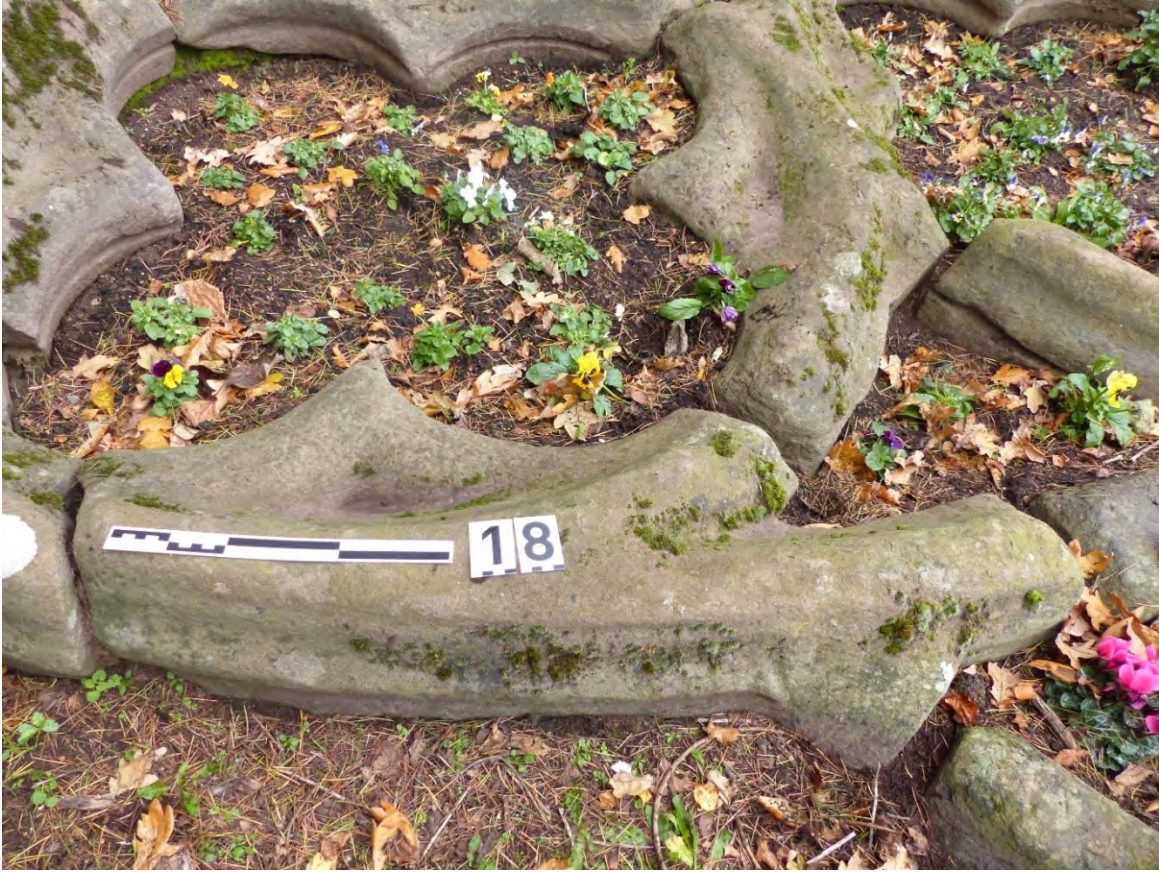
Date: 20/11/2021	Stone #: BP 2-18 SUAT cross reference # 18 Location 2	Recorded by: CS CD LT
Site: Balgay Park	Photo# 82

Damage Moss/lichen Tool marks -no longer plants in break

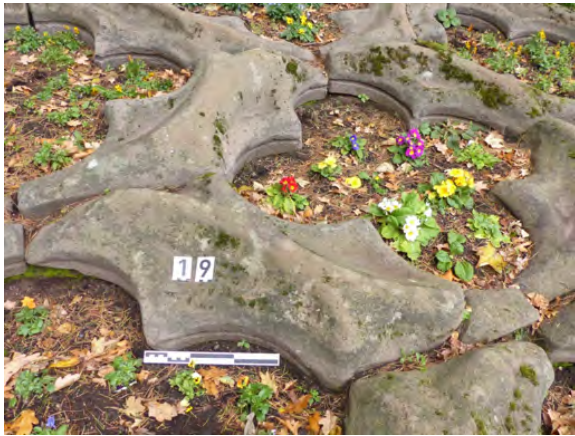
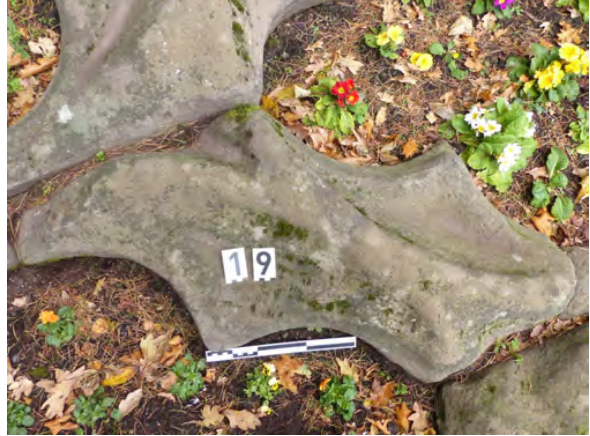
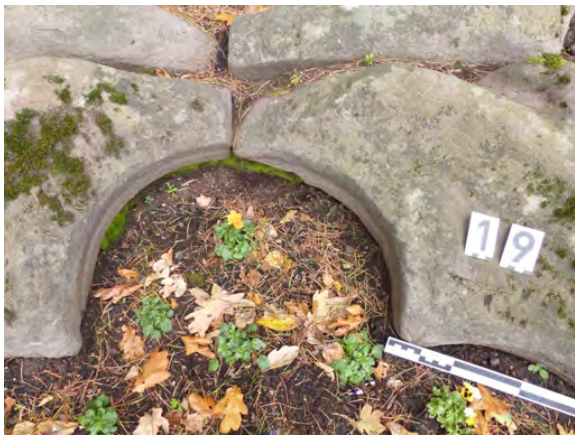
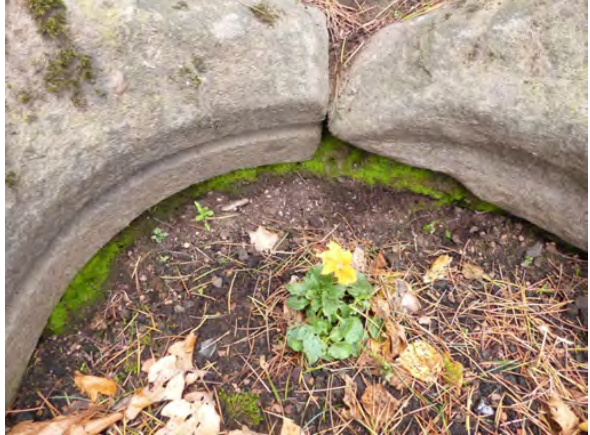
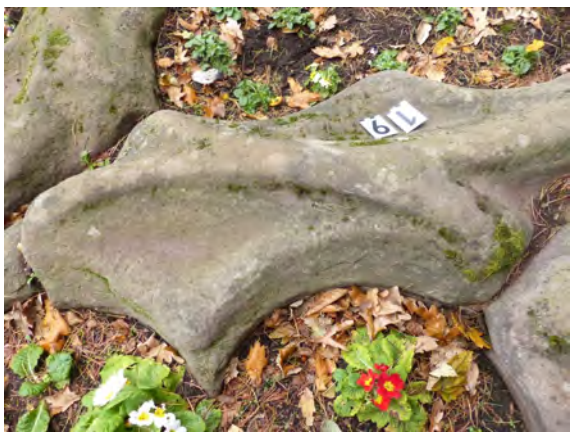
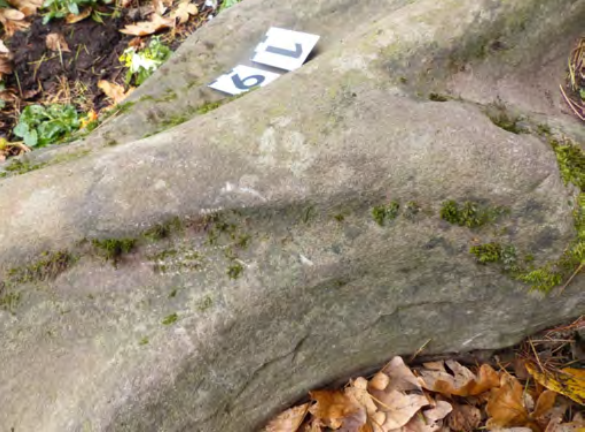
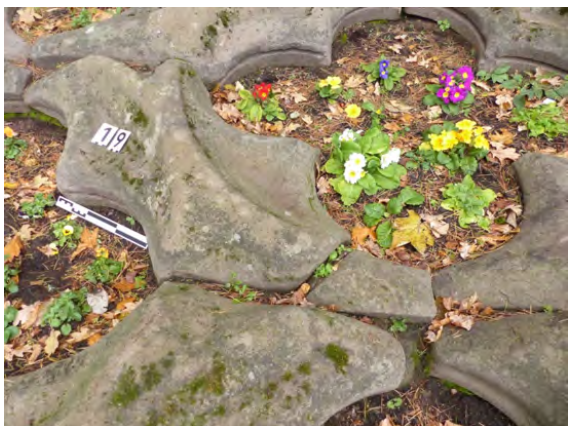
Date: 20/11/2021	Stone #: BP 2-19 SUAT cross reference # 19 Location 2	Recorded by: CS CD LT
Site: Balgay Park	Photos# 83-89

Damage: Moss on overhang
 Delamination (historic)
 Toolmarks (recent)
 Crack with moss growing in 160 cm
Recommendations: Use non-metal
 tools while gardening

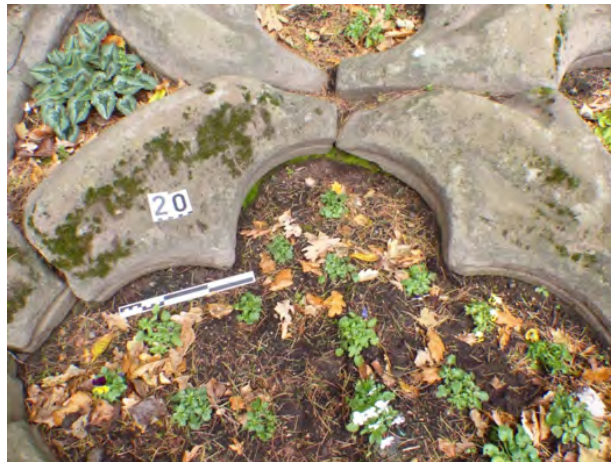
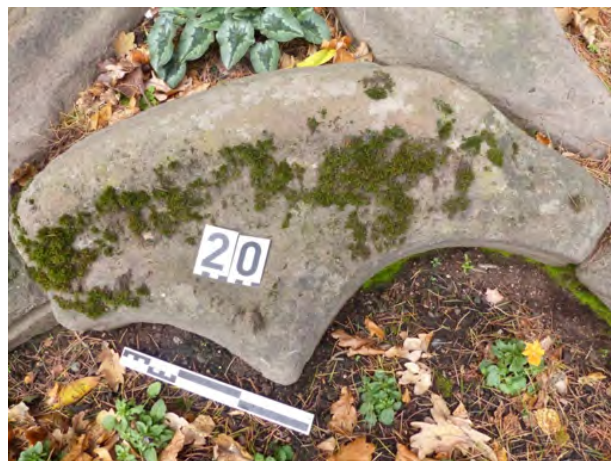
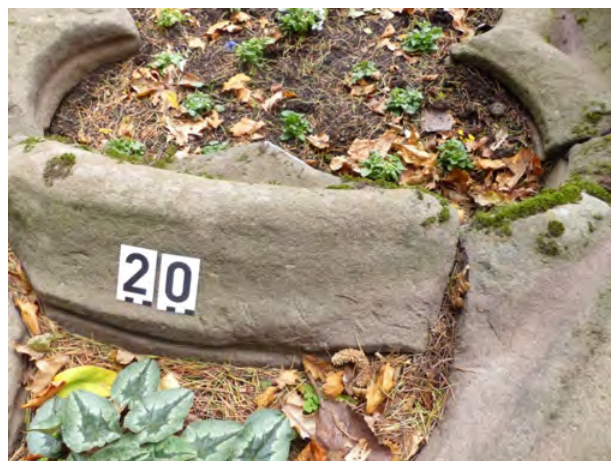
Date: 20/11/2021	Stone #: BP 2-20 SUAT cross reference # 20 Location 2	Recorded by: CS CD LT
Site: Balgay Park	Photos# 90-92

Damage: Moss
Inclusions
Historic delamination
Chip or possible damage associated with removal

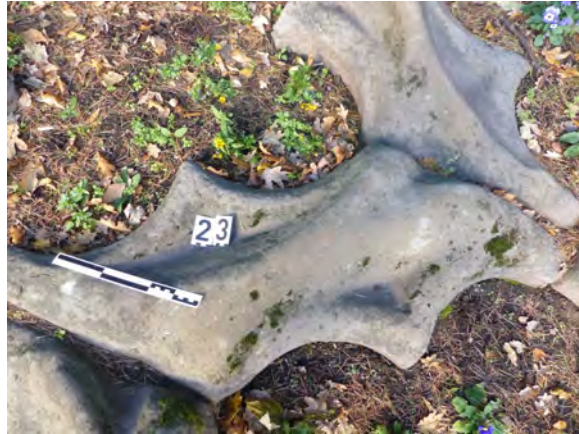
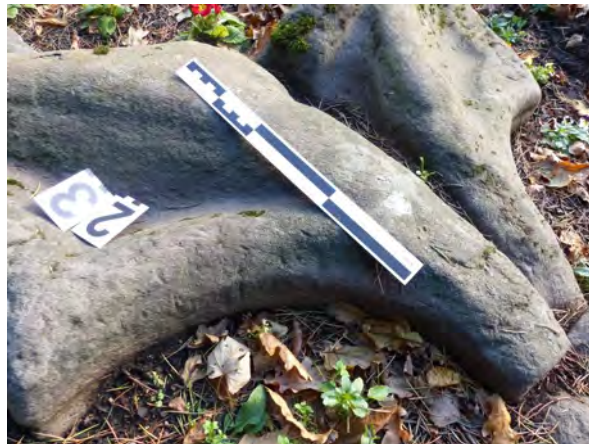
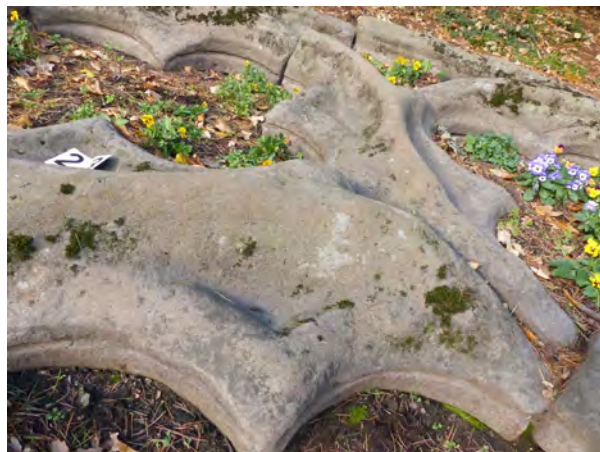
Date: 20/11/21	Stone #: BP 2-23 SUAT cross reference # 23 Location 2	Recorded by: CS CD LT
Site: Balgay Park	Photos# 99-100

Damage: Lichen
Some loss
Some delamination
Erosion
Abrasion
Peck mark
Possibly not original surface on end

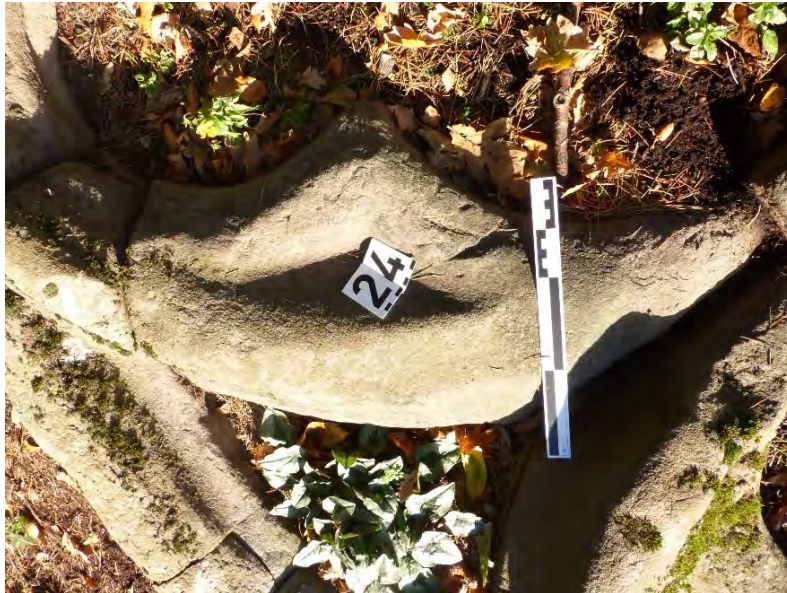
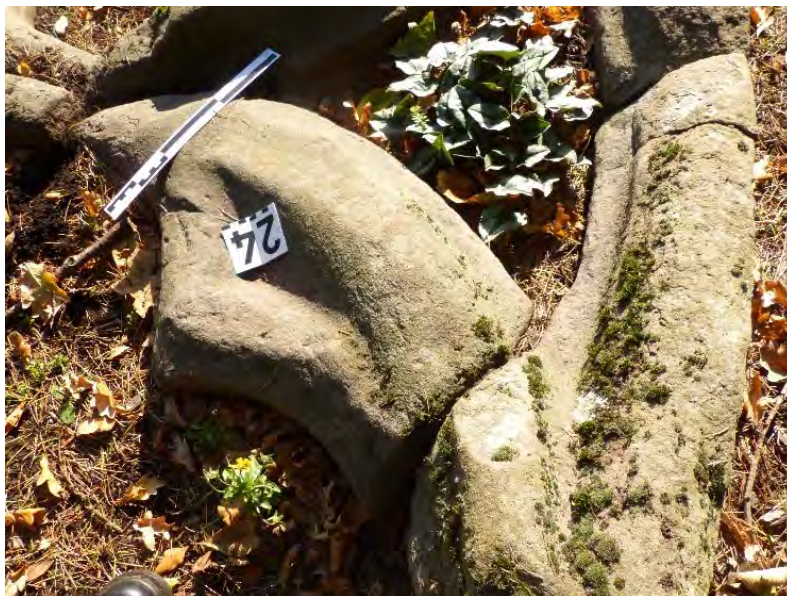
Date: 20/11/21	Stone #: BP 2-24 SUAT cross reference # 24 Location 2	Recorded by: CS CD LT
Site: Balgay Park	Photos# 102-103

Damage:
Delamination

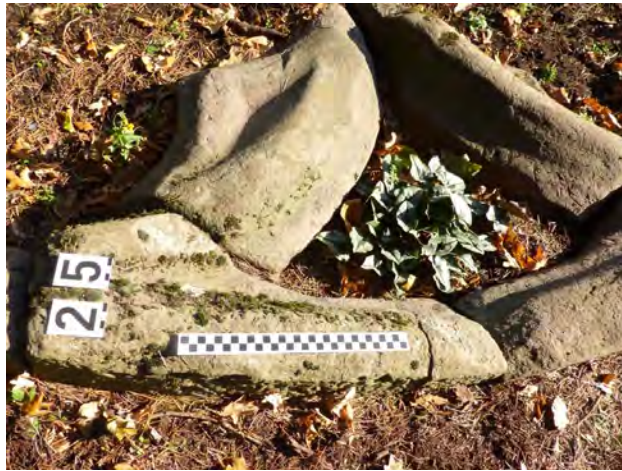
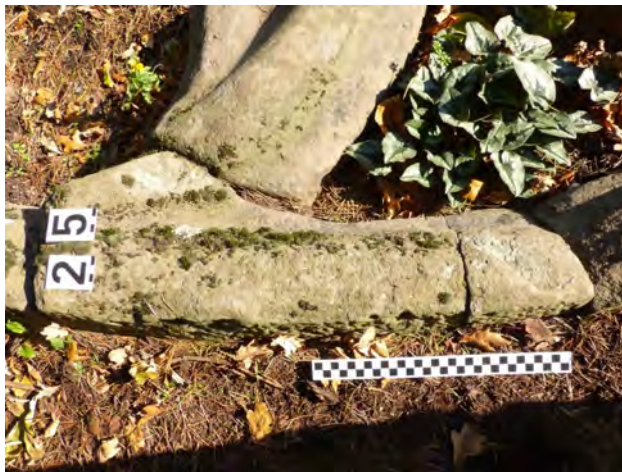
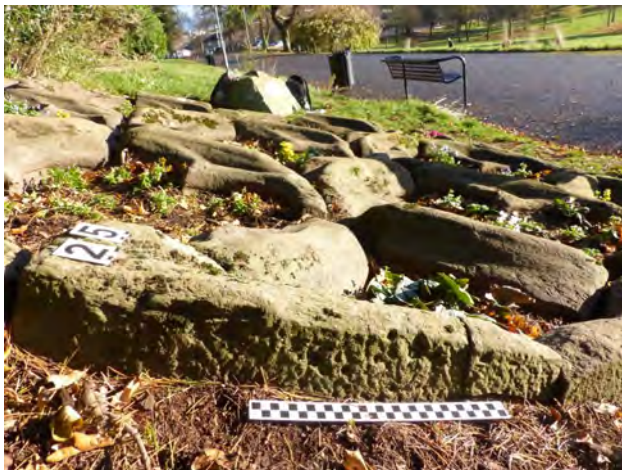
Date: 20/11/2021	Stone #: BP 2-25 SUAT cross reference # 25 Location 2	Recorded by: CS CD LT
Site: Balgay Park	Photos# 104-106

Damage:

Crack-Horizontal crack 100 mm. West side of stone. Full length of stone. Crack down to base level and continues below soil. Block 100 x 100 separate.

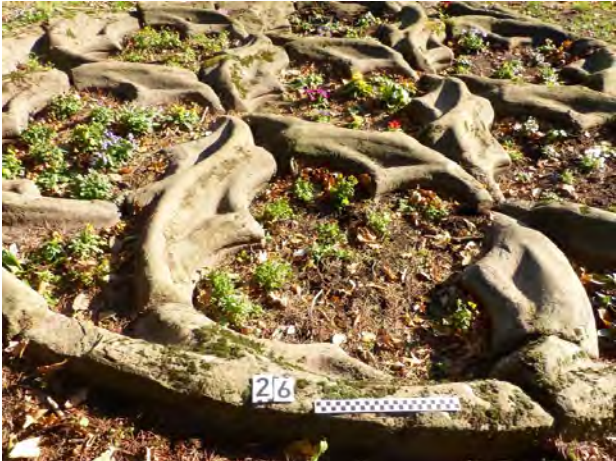
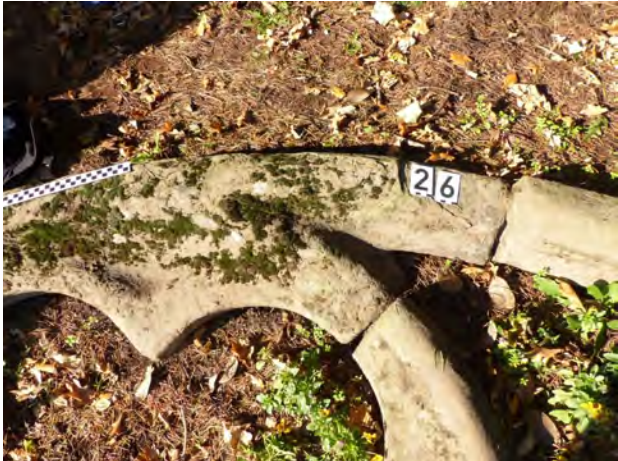
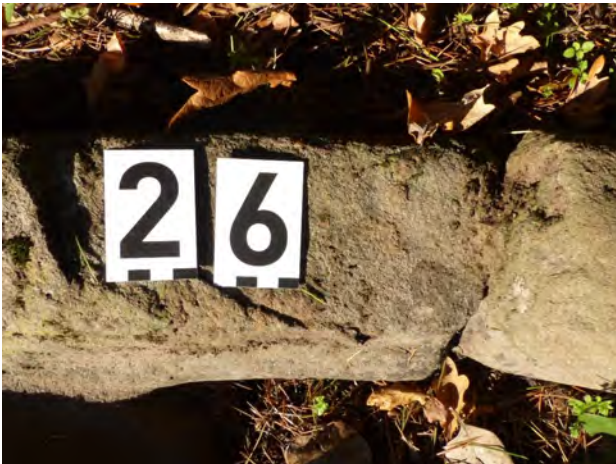
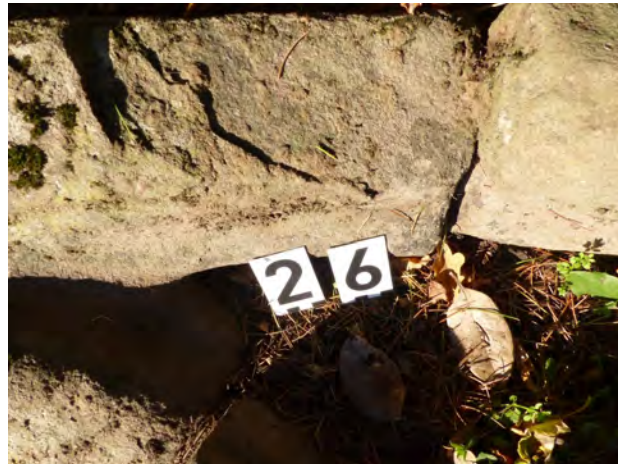
Date: 20/11/2021	Stone #: BP 2-26 SUAT cross reference # 26 Location 2	Recorded by: CS CD LT
Site: Balgay Park	Photos# 107-110	
<div>

</div>		
Damage: Delamination on ends

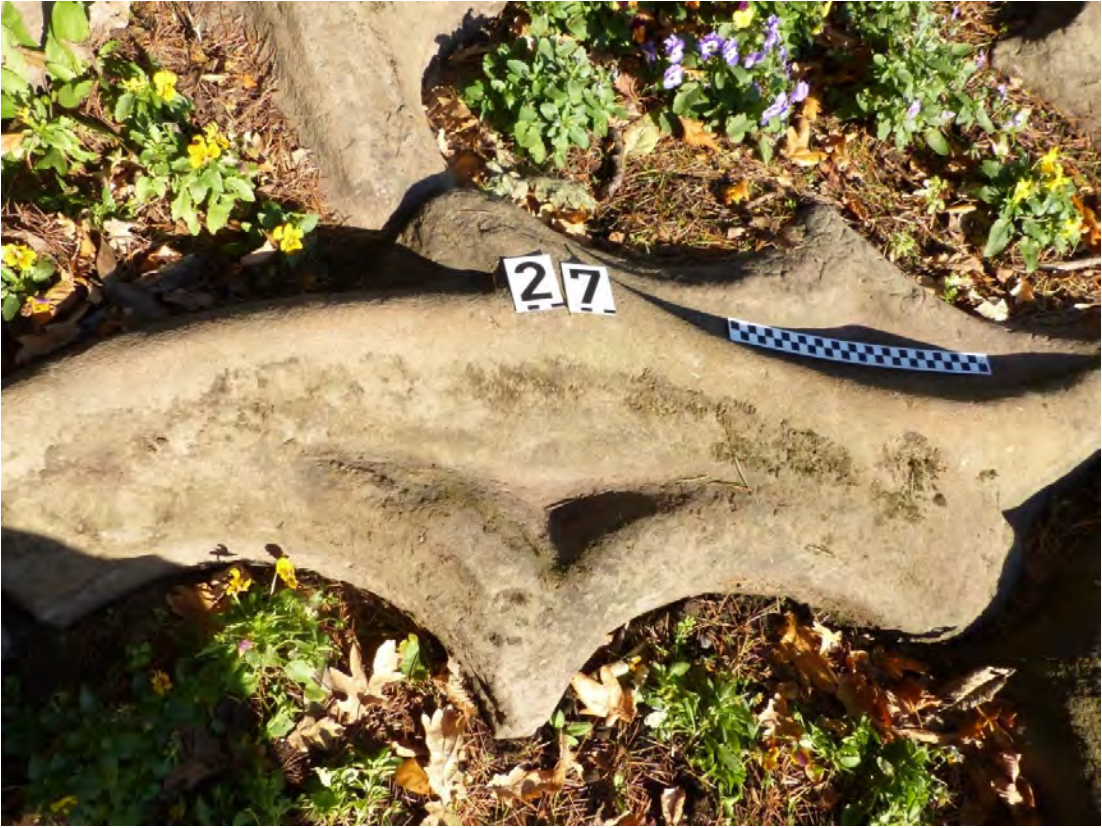
Date: 20/11/2021	Stone #: BP 2-27 SUAT cross reference # 27 Location 2	Recorded by: CS CD LT
Site: Balgay Park	Photo# 111

Damage: Abraded Peck marks-from lead removal? Recent scrapes

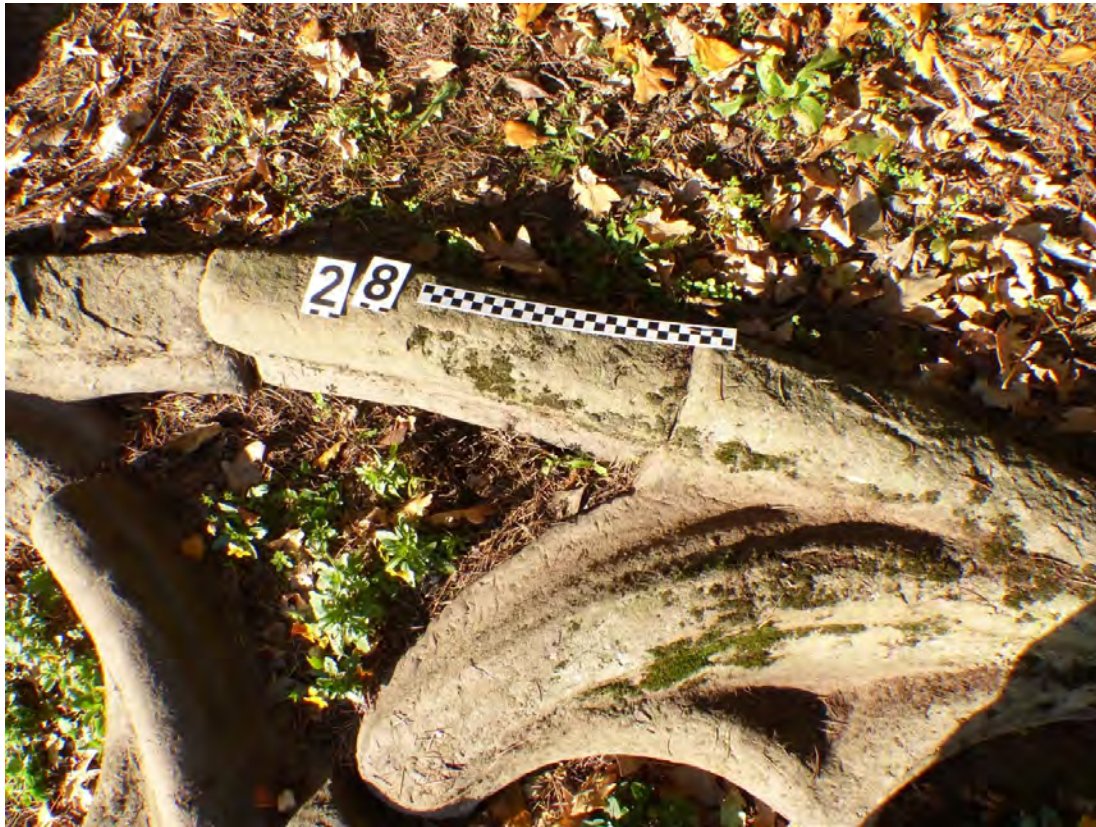
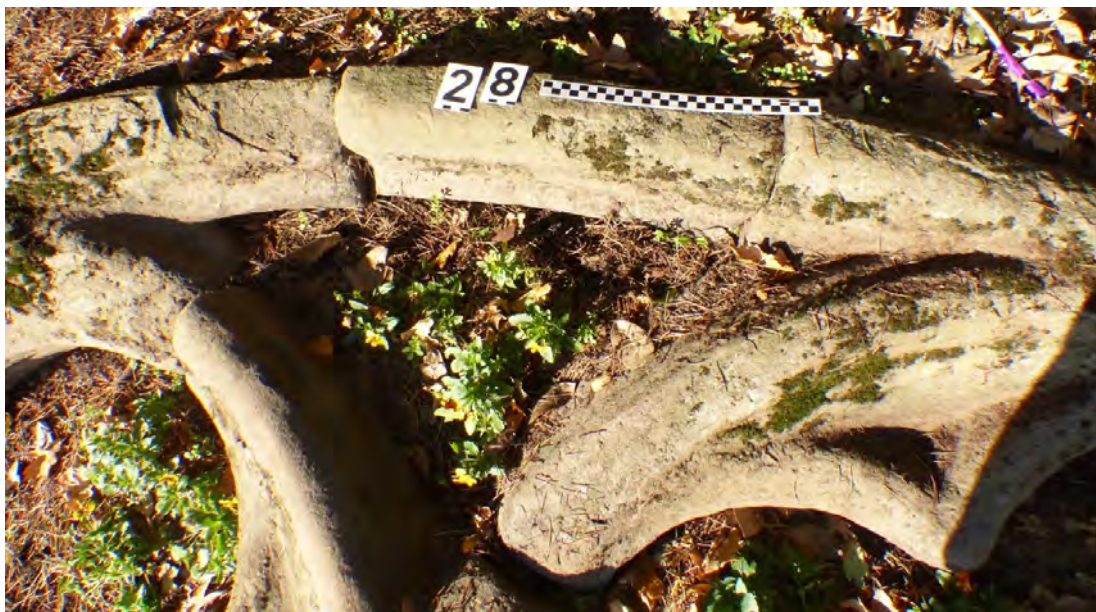
Date: 20/11/21	Stone #: BP 2-28 SUAT cross reference # 28 Location 2	Recorded by: CS CD LT
Site: Balgay Park	Photos# 112-113

Damage:
Delamination
Break on end
Tool marks
