Abertay Historical Society Fieldwork Division

Worked Stone Record

Stones from St Mary's Church in Balgay Park

Abertay Historical Society Field Division and Friends of Balgay recorded the stones in 2016 and undertook a condition check in 2021. The attached record sheets are from the 2021 condition.

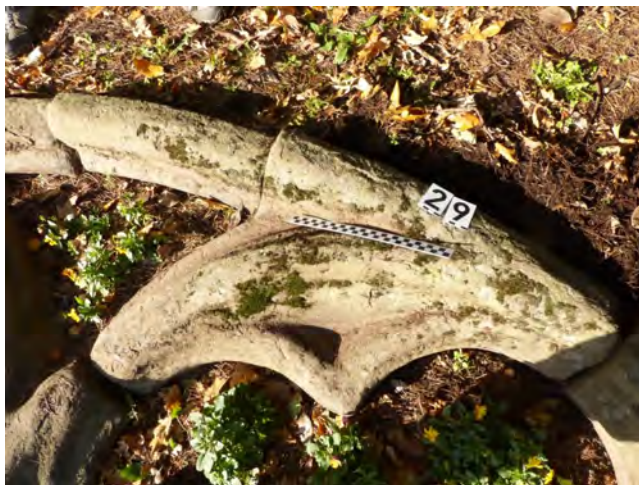
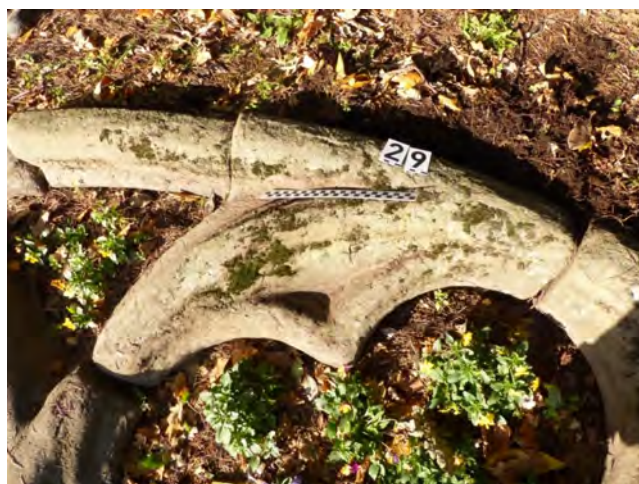
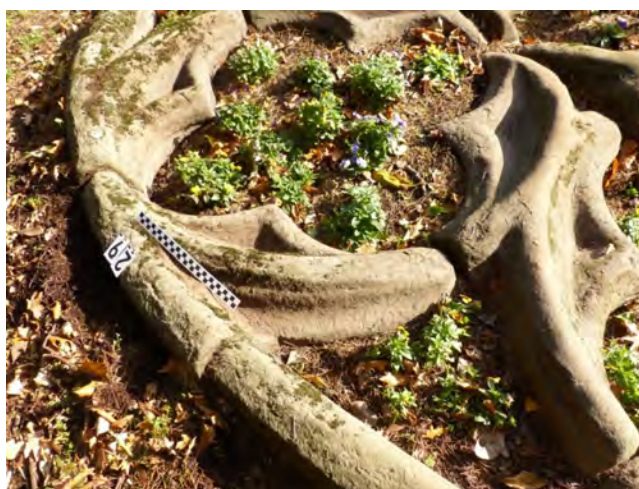
Date: 20/11/2021	Stone #: BP 2-29 SUAT cross reference # 29 Location 2	Recorded by: CS CD LT
Site: Balgay Park	Photos# 114-116

Damage:
Delamination
Peeling
Tool marks from lead removal
